**6F50/6F55 TRANSMISSION—SLUGGISH
ACCELERATION FROM 0-8 KM/H (0-5 MPH)
FOLLOWED BY A HARSH BUMP OR A SLIP ON
TAKE-OFF FOLLOWED BY A BUMP—BUILT ON OR
BEFORE 4/15/2011**

TSB 11-12-10

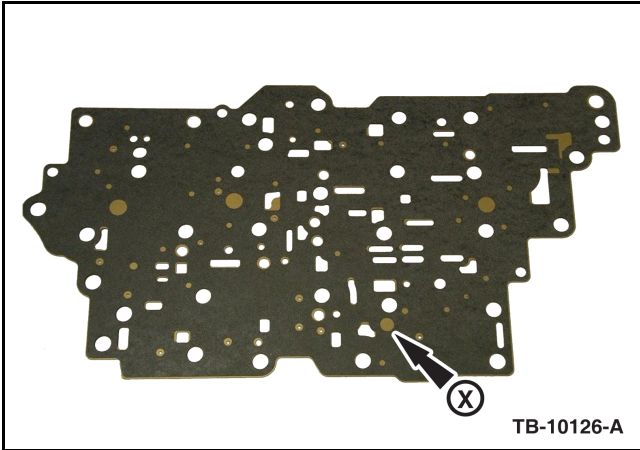
Figure 1 - Article 11-12-10

1. For all model years except 2009, proceed to Step 2. For 2009 model year vehicles, verify the transmission dipstick has MERCON® LV listed on the dipstick.
 - a. Yes - The dipstick has MERCON® LV listed on the dipstick; proceed to Step 2.
 - b. No - The dipstick does not have MERCON® LV listed on the dipstick; this procedure does not apply. Follow normal Workshop Manual diagnostics.
2. Reprogram the PCM to the latest calibration using IDS release 73.04 and higher. This new calibration is not included in the VCM 2011.5 DVD. Calibration files may also be obtained at www.motorcraft.com.
3. Remove the transmission valve body. Refer to the Workshop Manual (WSM), Section 307-01.
4. Replace both separator plates listed in the Parts List. The X identifies the hole in the valve body separator plate which will be eliminated. (Figure 1)

There is a new calibration and transmission valve body change to correct this condition. The valve body change was to delete one hole in the valve body separator plate and remove one check ball from the valve body in the same area where the hole in the separator plate was deleted.

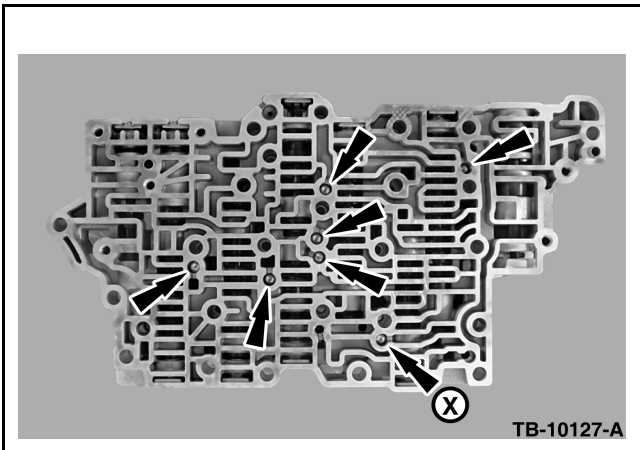
Figure 2 - Article 11-12-10

- a. Proper check ball locations on the remaining six (6) valve body check balls shown with arrows. (Figure 2)
6. Install transmission valve body. Refer to WSM, Section 307-01.

5. Remove one (1) check ball identified as X. (Figure 2)
