FORD:
2009-2012 Escape

MERCURY:
2009-2011 Mariner

TSB 12-2-2 (Continued)

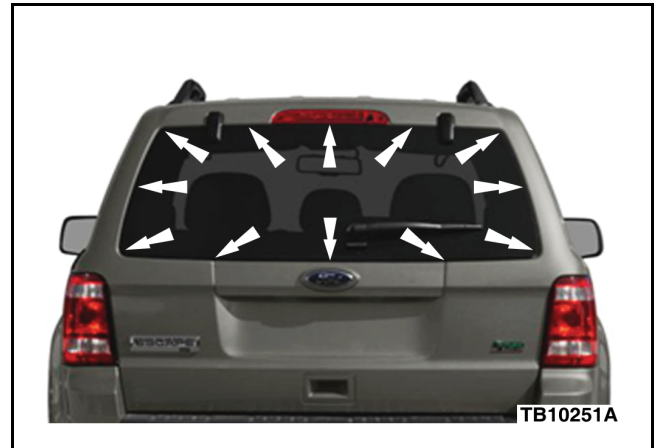
Figure 1 - Article 12-2-2

Some 2009-2012 Escape, 2009-2011 Mariner vehicles may exhibit an intermittent water leak originating from the liftgate glass/seal.

7. Remove all adhesive and residue from the liftgate glass opening, using 3M™ Specialty Adhesive Remover 38984.
 - a. Thoroughly soak rag with cleaner and remove adhesive.
8. Using one of the preferred methods below measure and record the gap between the liftgate flange and liftgate glass at twelve (12) different locations as shown. (Figure 1)

- (1) Use any type of soft modeling clay and insert softened balls of clay in twelve (12) locations. (Figure 1).
- (2) After the clay is firmly in place, close the liftgate glass until it latches. Making sure not to slam glass, causing the clay to not read the correct height dimensions.
- (3) Raise glass, and measure the depressions left in clay and record. (Figure 1)
- (4) Remove clay pieces one at a time, use a marker and make a dot on sheet metal of each location where you measured.

- (2) Use a metal ruler or equivalent to measure and record the gap between the liftgate flange and liftgate glass in twelve (12) locations as shown. Use a marker to indicate where each measurement was made. (Figure 1)
9. The specification for glass to sheet metal flange gap is 14 mm \pm 3 mm (9/16" \pm 1/8"). Using the recorded measurements, adjust the sheet metal flange with a pair of duck bill pliers or flange pliers until the flange is within specification.
 - a. Steps 8a or 8b may need to be repeated 2-3 times.
10. Unclip struts one at a time and install a new seal around liftgate window opening.
 - a. Start at the center bottom seal may at first appear to be too long, any slack should be worked into the corners.
11. Reconnect wiring and window struts.
