AFTERMARKET POWERTRAIN CONTROL MODULE CALIBRATION, NON-FACTORY MODIFICATION OR AFTERMARKET COMPONENTS

TSB 10-2-6

FORD:
2010 Taurus, Flex

LINCOLN:
2010 MKS, MKT

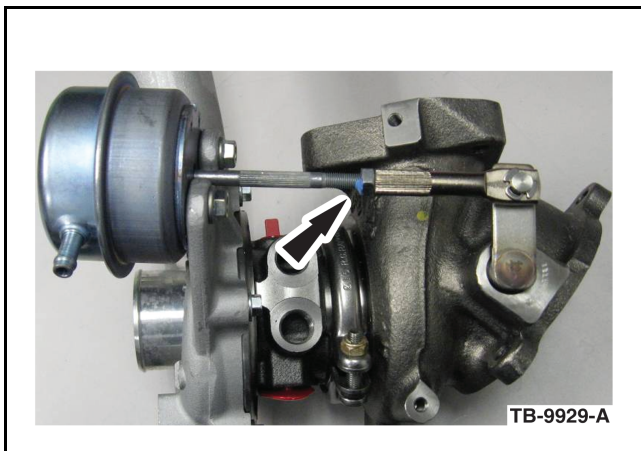
Figure 1 - Article 10-2-6

The full load output of some turbocharged engines will increase if the wastegate spring pre-tension is increased. This is not the case with the EcoBoost engine. Adjusting the wastegate pre-tension out of the specified range can result in DTCs. A tamper evident paint dot has been applied to the wastegate actuator adjustment mechanism to make modifications more apparent.

Wastegate Tamper Evident Paint Dot

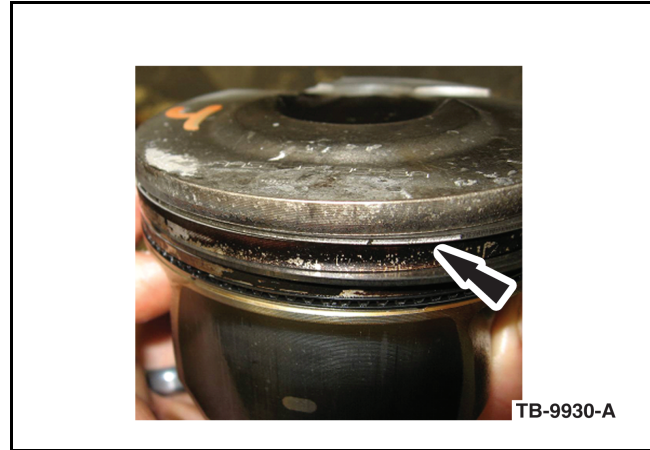
Figure 2 - Article 10-2-6

Piston Damage

Top ring delaminating and top ring land pitting caused by excessive spark advance.

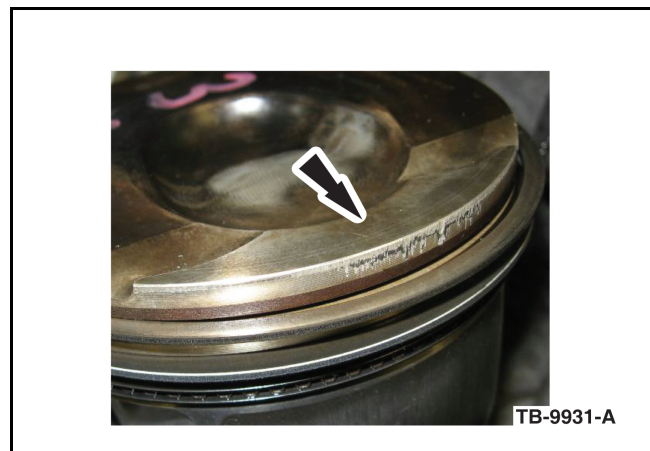
Figure 3 - Article 10-2-6

Light Knock Damage

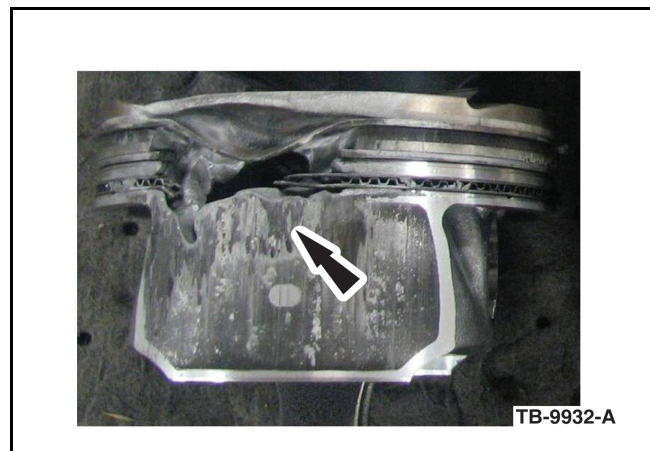
Figure 4 - Article 10-2-6

Heavy Knock Damage

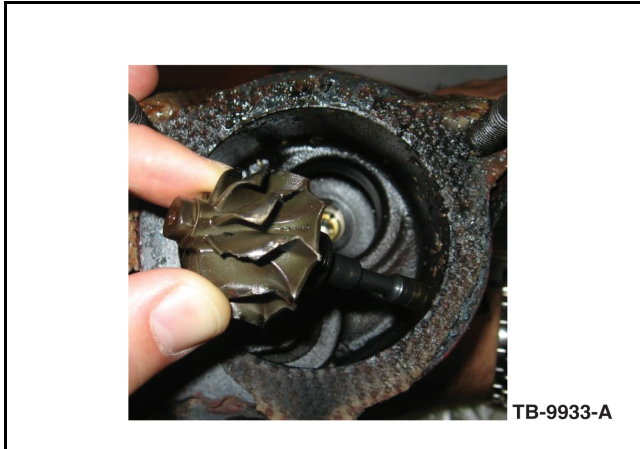
Figure 5 - Article 10-2-6

The system may be particularly susceptible to flexible air ducts between the air filter and the compressors. Restrictions on either side of the compressor can result in over-speeding the turbo (Figures 5-6).

Turbo Over-Speed Failure

Turbine wheel after an over-speed event.

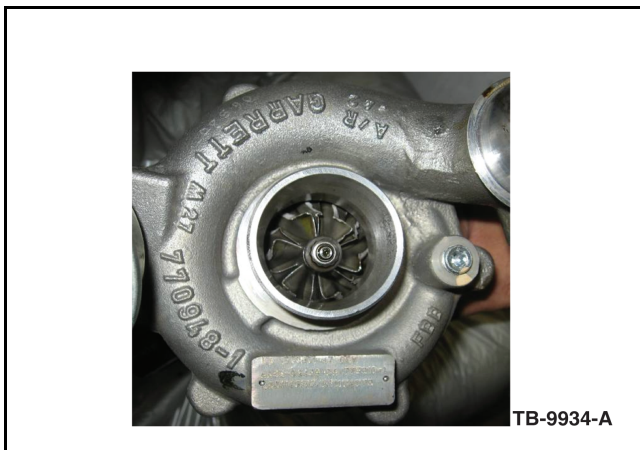
Figure 6 - Article 10-2-6

Compressor Damage After An Over-Speed Event

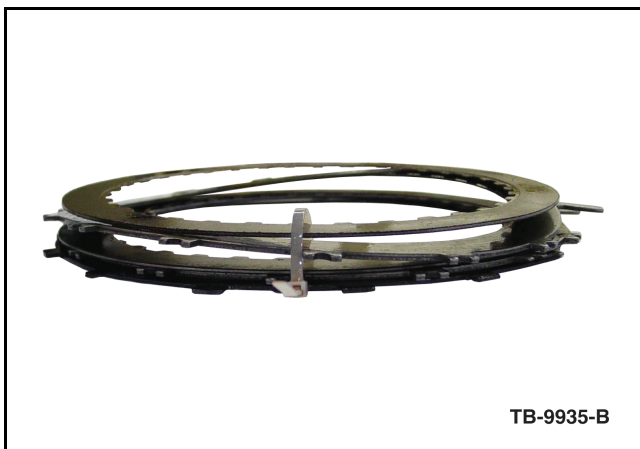
Figure 7 - Article 10-2-6

Damaged C1234 Clutch, Warped Separator Plates

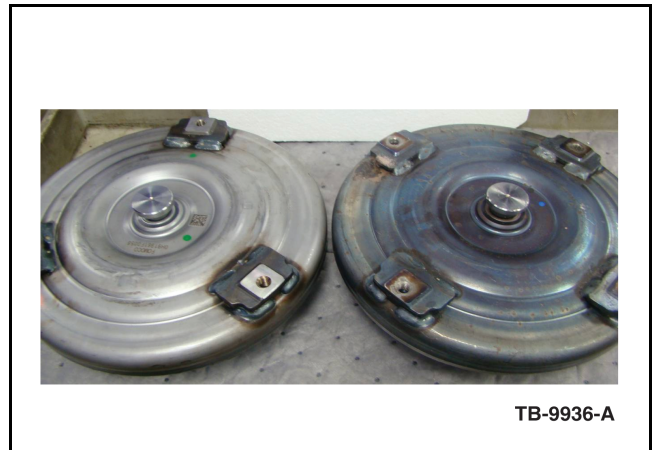
Figure 8 - Article 10-2-6

Normal Torque Converter (Left Side) Compared To An Overheated Torque Converter (Right Side)

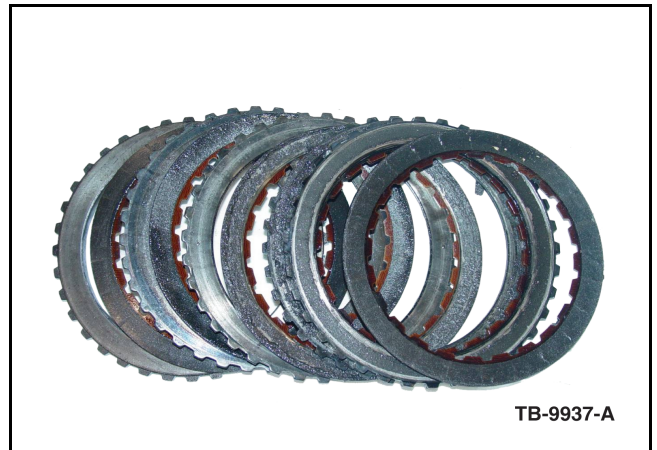
Figure 9 - Article 10-2-6

Damaged C456 Clutch

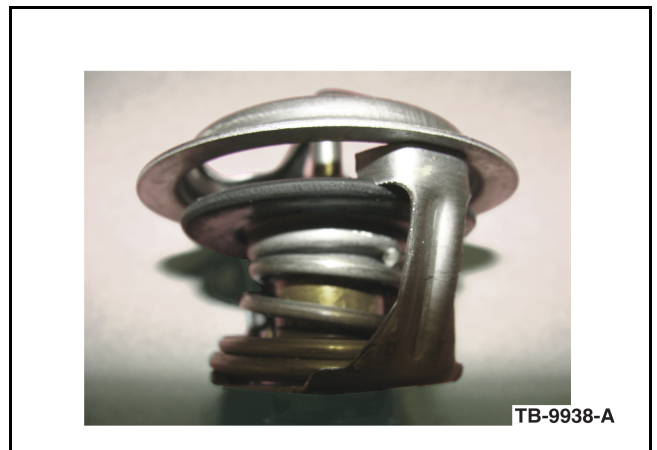
Figure 10 - Article 10-2-6

Blocking open the thermostat may reduce the coolant flow to the turbo chargers.

Modified Thermostat Opening
