FORD:

2009-2012 F-150

TSB 12-4-4 (Continued)

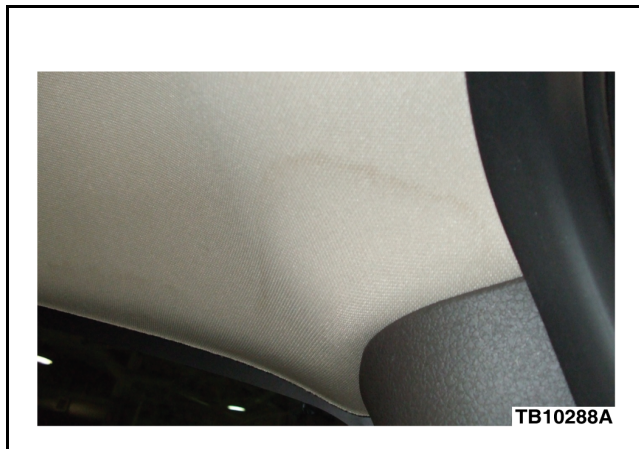
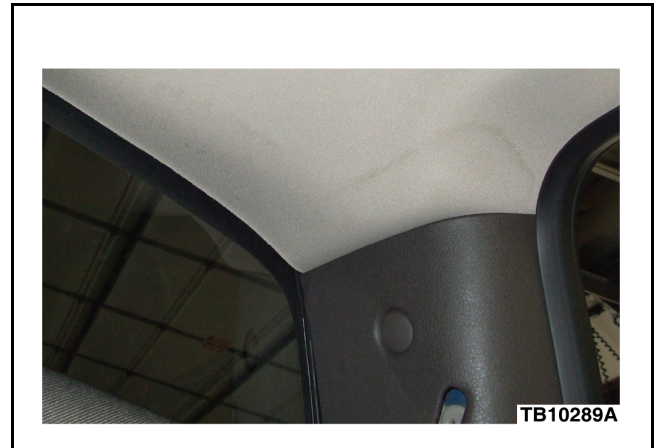
Some 2009-2012 F-150 may experience water staining of the rear portion of the headliner in the area(s) above the back glass and at both cab corners due to the high mounted stoplamp assembly leaking water.

1. Replace the high mounted stoplamp assembly. Refer to Workshop Manual, Section 417-01.
2. Fully open all vehicle doors.
3. Identify the rear area of the headliner to be cleaned. (Figures 1 and 2)
