## 3.5L GTDI—INTERMITTENT STUMBLE/MISFIRE ON ACCELERATION FROM HIGHWAY CRUISE IN HUMID OR DAMP CONDITIONS WITH POSSIBLE DTC P0304, P0305, P0306, OR P0430

TSB 13-8-1

2011-2012 F-150

This article supersedes TSB **13-3-3** to update the Service Procedure and Part List.

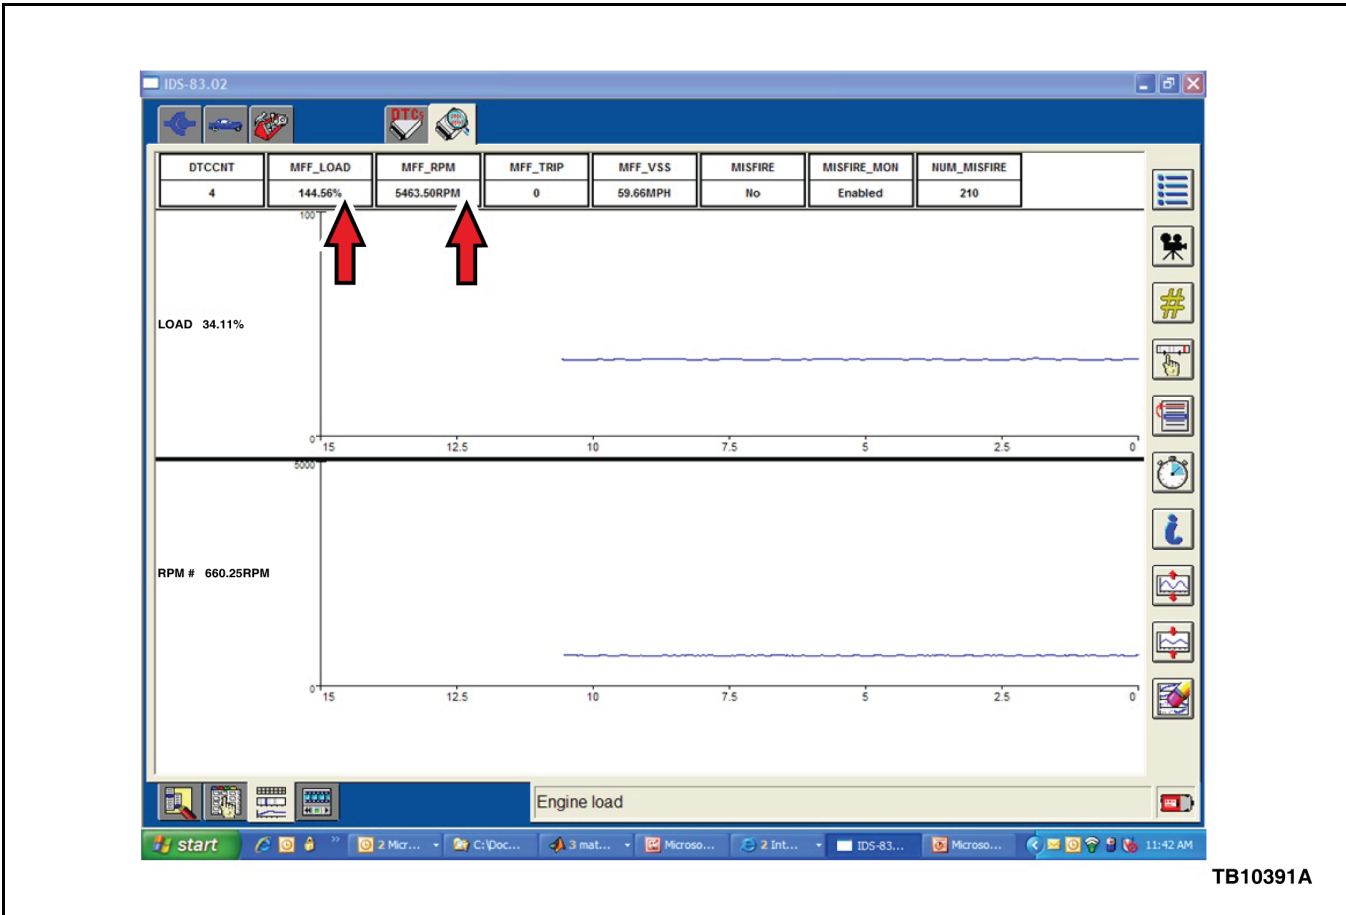
Figure 1 - Article 13-8-1

- a. Select Toolbox
  - b. Then Data Logger
  - c. Then Modules
  - d. Then PCM
  - e. Next, select the following PIDs: MFF\_LOAD and MFF\_RPM.
2. Is the misfire concern only repeatable in humid or damp conditions?
    - a. Yes - Proceed to Step 3.
    - b. No - This article does not apply. Refer to Powertrain Control/Emissions Diagnosis (PC/ED) Manual Section 3: Powertrain Symptom Index to inspect such areas as Ignition, Compression, and Injection.
  3. Does the Misfire Freeze Frame Data indicate engine speed above 2500 rpm and load 100% or above? (Figure 1)

- a. Yes - Proceed to Step 4.
  - b. No - This article does not apply. Refer to PC/ED Manual Section 3: Powertrain Symptom Index to inspect such areas as Ignition, Compression, and Injection.
4. Is vehicle equipped with latest level charge air cooler, engineering part number BL34-9L440-AE? (Figure 2)

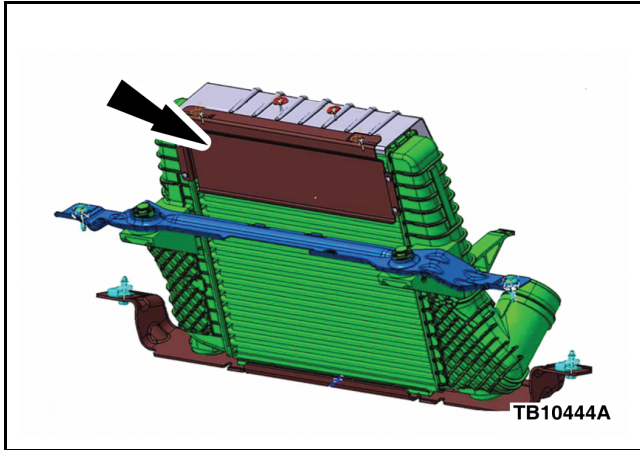
Figure 3 - Article 13-8-1

- 5. Is DTC P0430 present?
  - a. Yes - replace the left hand catalytic converter. Refer to Workshop Manual (WSM), Section 309-00. Proceed to Step 6.
  - b. No - Proceed to Step 6.
- 6. Is the Charge Air Cooler equipped with the top air deflector? (Figure 3)

- a. Yes - remove and discard. Refer to WSM, Section 303-12. Proceed to Step 7.
  - b. No - Proceed to Step 7.
7. Install revised bottom air deflector.
- a. Make sure that the lower forward facing bottom seven (7) tubes and eight (8) rows of fins on the Charge Air Cooler are dry and free of dirt and debris. (Figure 4)
