**FORD:**  
2013 C-MAX

**ISSUE**

## TSB 12-12-6 (Continued)

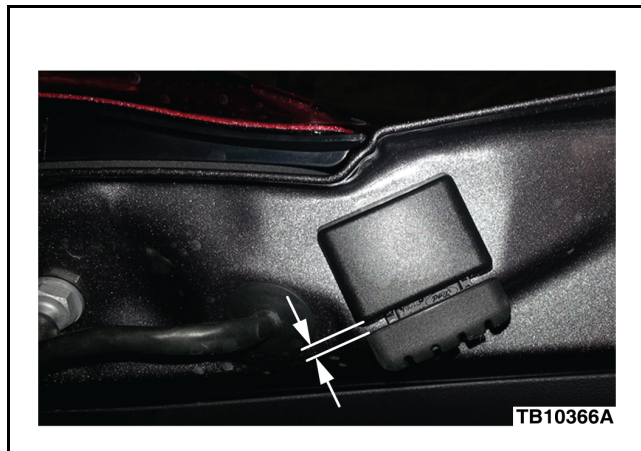
Figure 1 - Article 12-12-6

1. Open liftgate and measure the gap between the upper cover and lower portion of the stop bumpers on the right and left sides of the vehicle. (Figure 1)

2. Is the gap greater than 6.0 mm (15/64")?
  - a. Yes - proceed to Step 3.
  - b. No - this article does not apply, refer to Workshop Manual (WSM), Section 413-01 for normal diagnostics.

5. Adjust the stop to achieve 5 mm - 6 mm (13/64"-15/64") gap between upper cover and lower portion of the stop (Figure 1).
6. Torque screw(s) to 4 N•m (35 lb-in).
  - a. It is necessary to install the upper cover to measure the gap. (Figure 1)

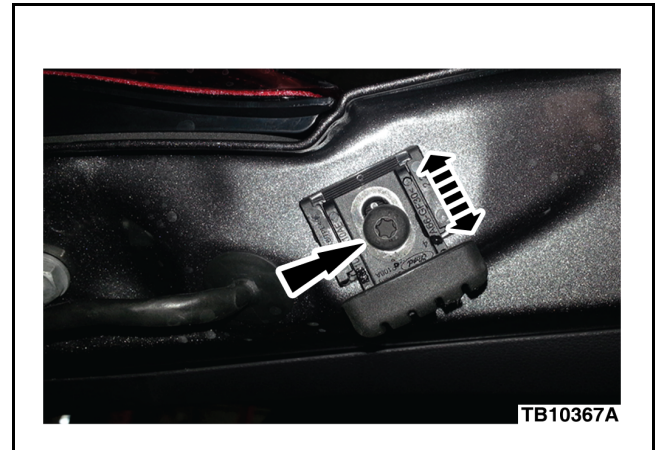
Figure 2 - Article 12-12-6

3. Remove the upper cover using a suitable trim removal tool.
4. Loosen the stop bumper screw(s) (Figure 2)
