FORD:

2011-2013 Taurus, Explorer, Flex

LINCOLN:

2011-2013 MKS, MKT

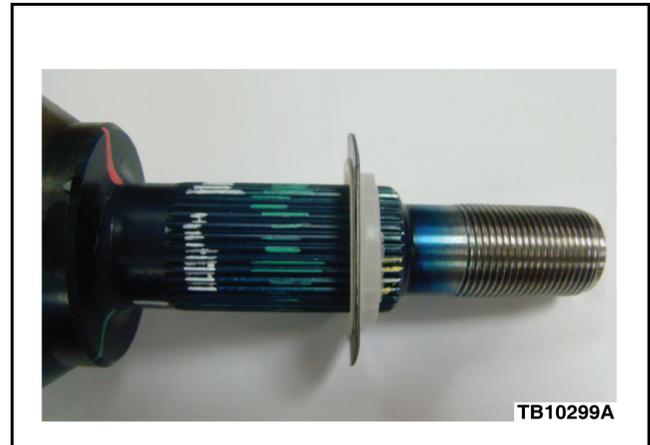
Figure 2 - Article 13-5-14

Some 2011-2013 Explorer, Flex, Taurus, MKT and MKS vehicles may exhibit a noise that could be described as ting, pop or click noise from the front wheel area when accelerating from a stop or when shifting between drive/reverse and/or reverse/drive.

1. Separate halfshaft from wheel hub. Refer to Workshop Manual (WSM), Section 205-04.
 - a. Do not remove halfshafts from transmission or power transfer unit (PTU).
2. Install one (1) thrust washer, metal surface first, over the halfshaft splines until the metal ring is flat against the wheel bearing mating surface. The nylon surface should face outward toward the hub/splines. (Figures 1 and 2)
