| General Service Bulletin (GSB): | Brake Disc Servicing Tips |
| GSB Overview: | This bulletin is a supplement to Workshop Manual (WSM) procedures. The purpose is to assist the dealership technician with determining the correct procedure for warranty repairs. |

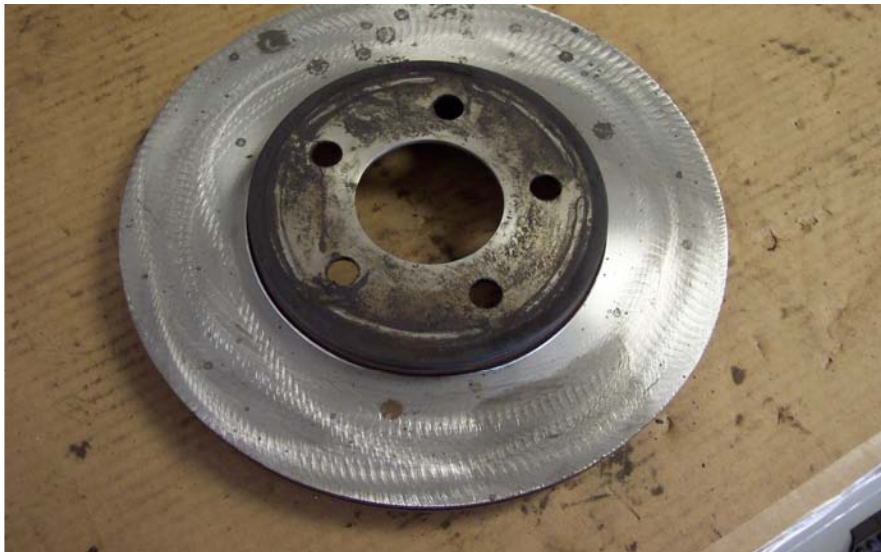
**Description:** The brake disc has machining marks or a chattering appearance across the surface.

**Cause:** This is the result of incorrect machining. Potential root causes could be depth of cut was too great, speed of the cutter was too fast or too slow, the angle of the cutting bit was incorrect, worn cutting bits, or vibration/silencer not installed.

**Warranty Status:** Not warrantable – technician error.

In this example – it appears the brake disc may have been in contact with a surface sander or grinding wheel of some sort. This would not be warrantable.

**Repair:** The brake disc can be re-machined if there is enough remaining thickness. If the disc cannot be machined the brake disc must be replaced.

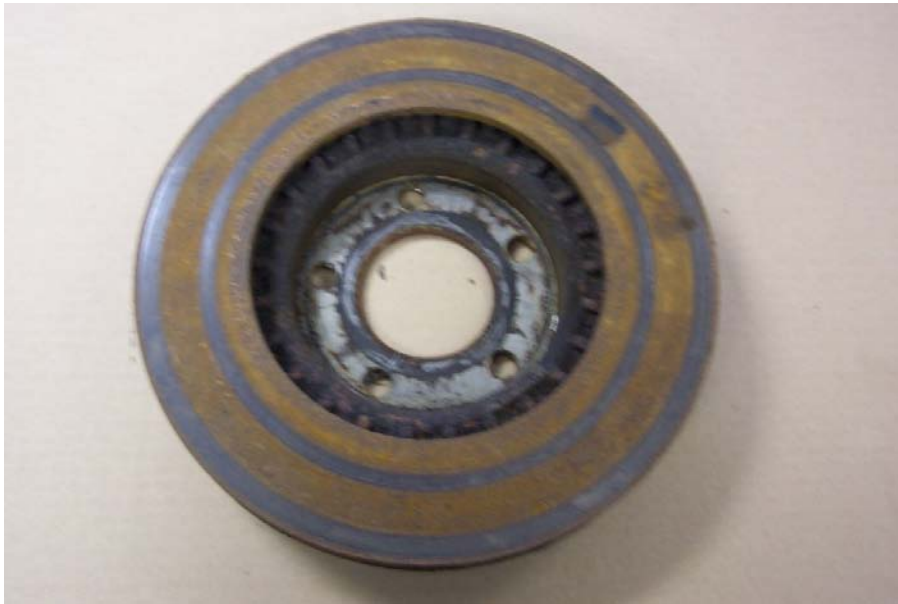
**Description:** The brake disc has the rust or pitting across the surface.

**Cause:** Exposure to the elements.

In this example – the customer returned the vehicle for a brake vibration during the coverage period. The surface is heavily rusted causing the concern. This repair would be warrantable.

**Repair:** The brake disc can be re-machined if there is enough remaining thickness. If the disc cannot be machined the brake disc must be replaced.

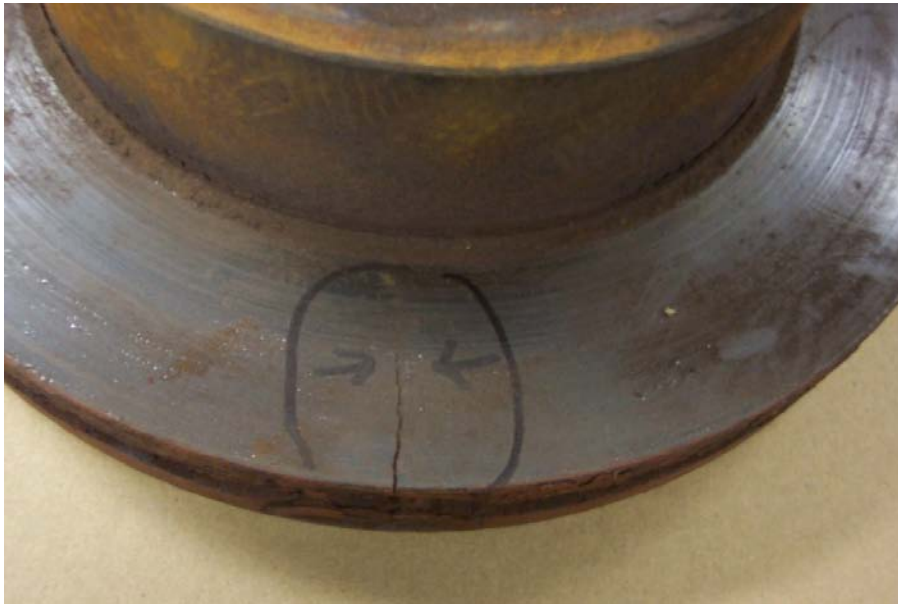
**Description:** The brake disc has a crack.

**Cause:** Possible impact damage, material defect or excessive heat.

In this example, there was no evidence of impact damage or collision so the repair would be warrantable if within warranty coverage period. Refer to Warranty and Policy Manual.

**Repair:** Replace the brake disc. Do not attempt to machine / resurface a part which is cracked.

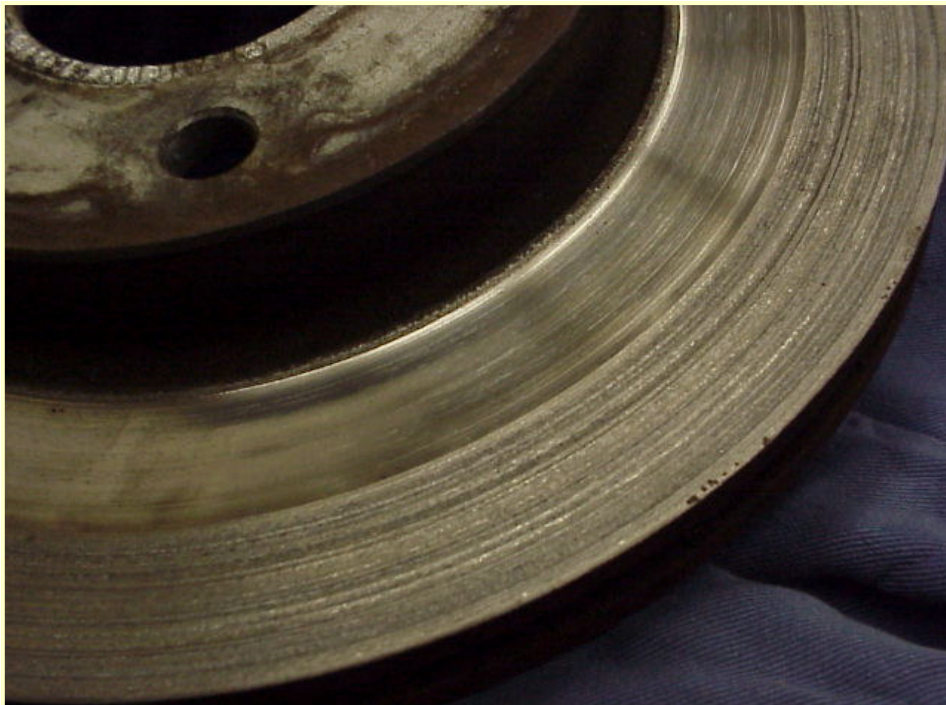
**Description:** The brake disc has grooves or scoring marks in the surface

**Cause:** Grooving or scoring can be caused by a faulty component, trapped foreign object or failure to replace the brake pads when required. However some amount of grooving/scoring is a result of normal wear.

In this example, deep grooves exist and measuring determined that machining / resurfacing would take the material below the minimum thickness specification. The brake pads had worn down to the backing plate through normal use and this brake disc was not eligible for warranty.

**Repair:** Generally, minor grooving less than 0.078 in (2 mm) is not an issue and should not be addressed. In cases where severe grooving or scoring of 0.078 in (2 mm) or more exists, or if the the customer expresses concern of brake roughness, brake disc can be re-machined if there is enough remaining thickness. If the brake disc cannot be machined it must be replaced. In cases of severe grooving, inspect the brake pad to determine if there is an object caught up in the pad causing the grooving.

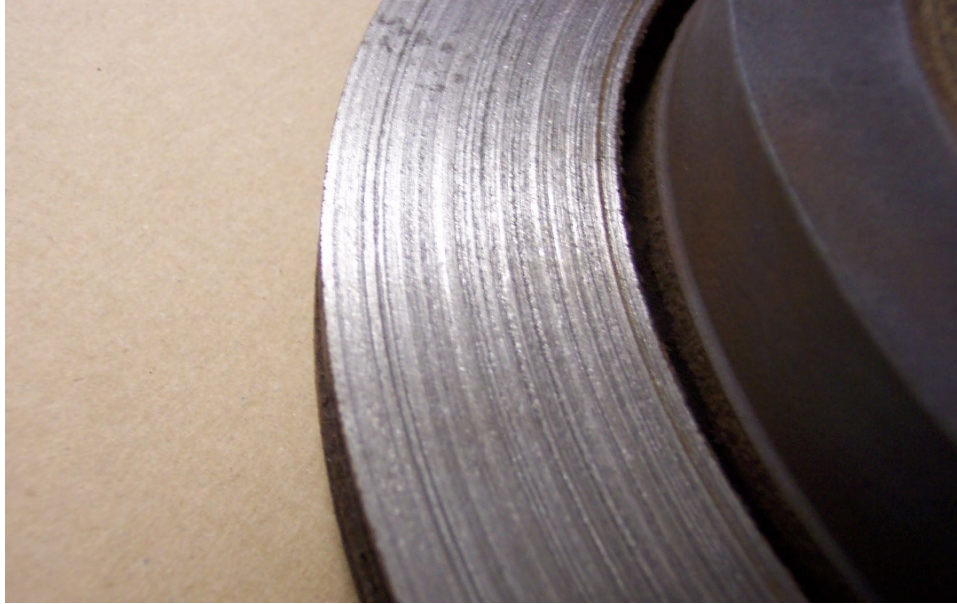
In this example, the scoring was able to be machined without reducing thickness below the minimum specification in the WSM. This disc was machined but it was determined the normal warranty coverage for wear was exceeded and the repair was customer responsibility.
