**FORD:**

2016-2017 Explorer

## TSB 17-0044 (Continued)

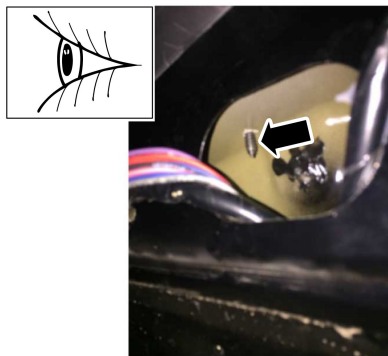
Figure 1 - Article 17-0044

Any hole or added fasteners in the body must be thoroughly and permanently sealed with Motorcraft® Seam Sealer or foil backed mastic patch. (Figure 1)

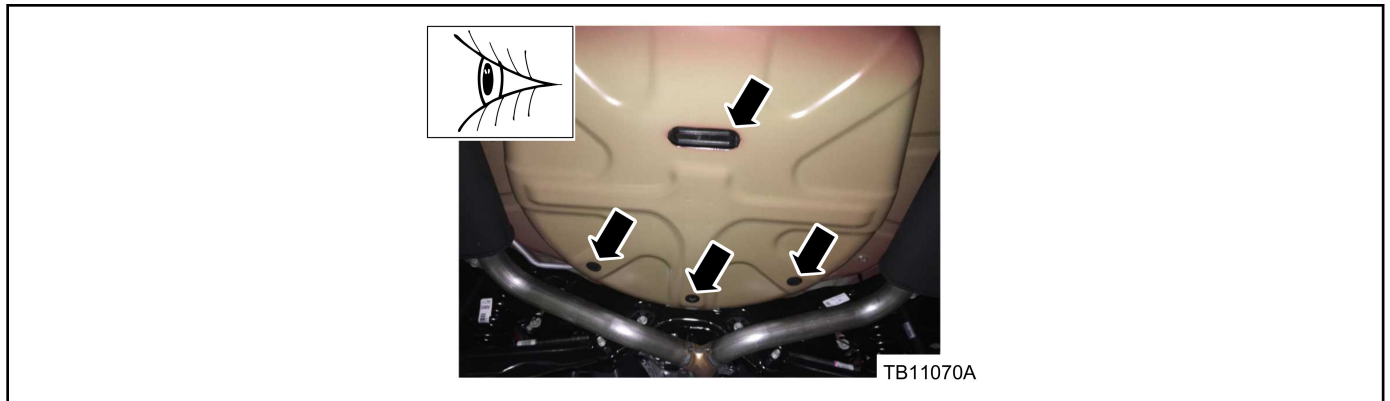
Figure 2 - Article 17-0044

- d. Rear end underbody sheet metal/body plugs. (Figure 2)

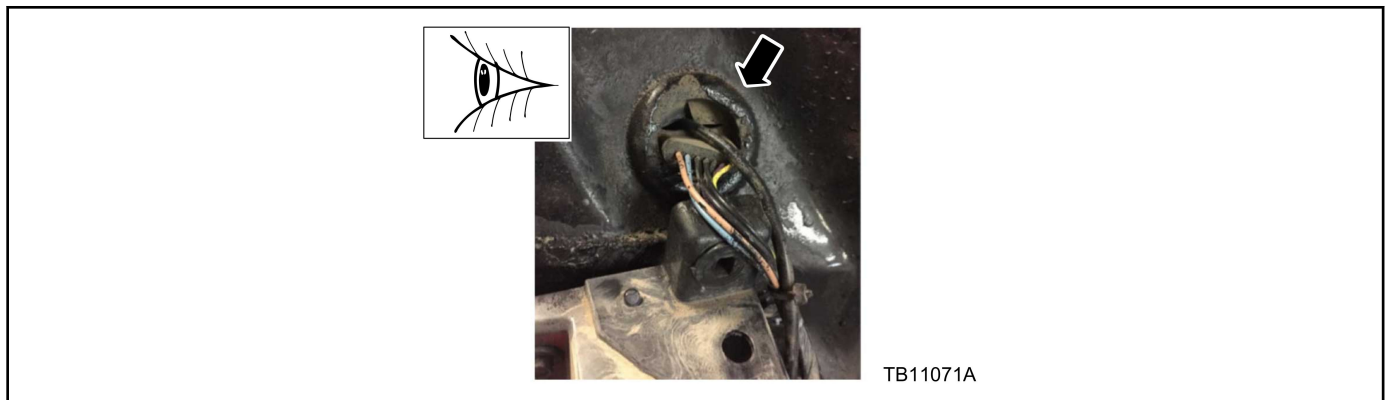
Figure 3 - Article 17-0044

- e. Behind left and right rear lamp assemblies. (Figure 3)

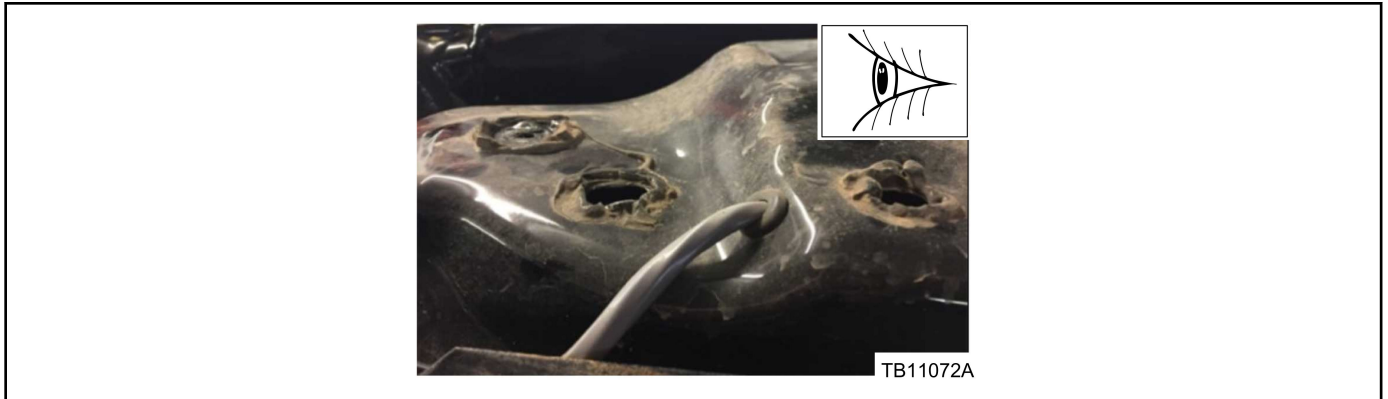
Figure 4 - Article 17-0044

- f. Spoiler attachment to the liftgate sheet metal. Improper spoiler sealing. (Figure 4)

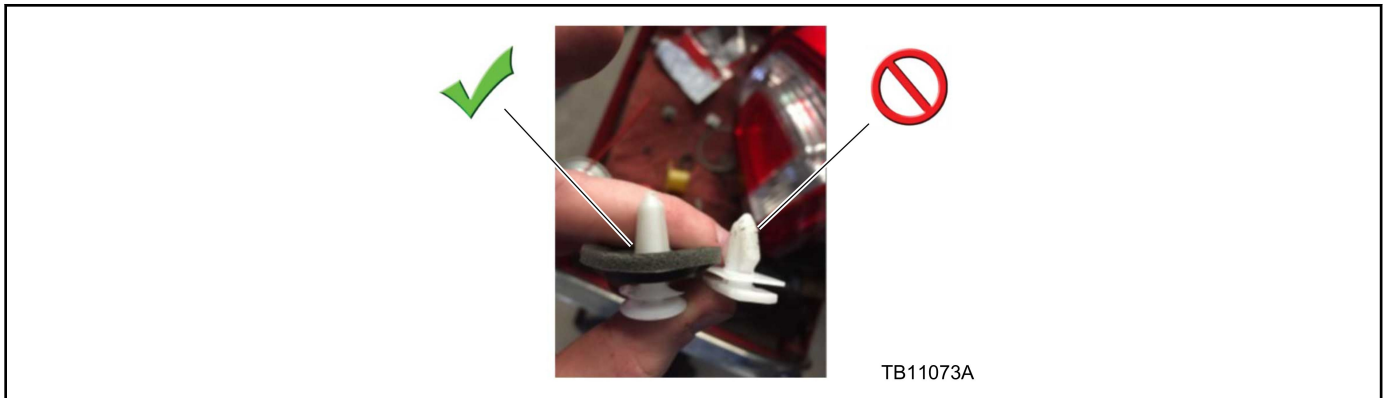
Figure 5 - Article 17-0044

- (1) Correct spoiler to liftgate fastener (left) incorrect fastener (right) (Figure 5)

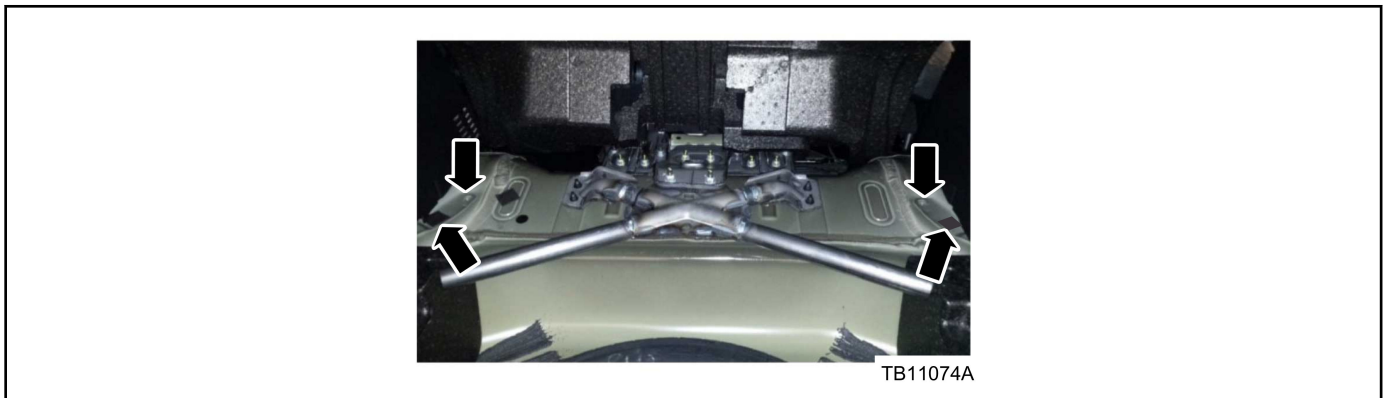
Figure 6 - Article 17-0044

- g. Rear load floor bolt holes (may require removal of hardware and/or electronics). Under the rear load floor there are 4 threaded bolt holes (2 on the left side and 2 on the right). On police units with no third row seat the front bolt hole is used to secure the load floor. The rear load floor bolt hole on each side should be sealed with mastic patch. (Figure 6)

- (1) Verify that patches are present over the rear hole on the left and right sides. Complete removal of the load floor may not be required. Remove the two fasteners and partially raise the load floor to inspect for the mastic patch. Seal with mastic patch if not present.

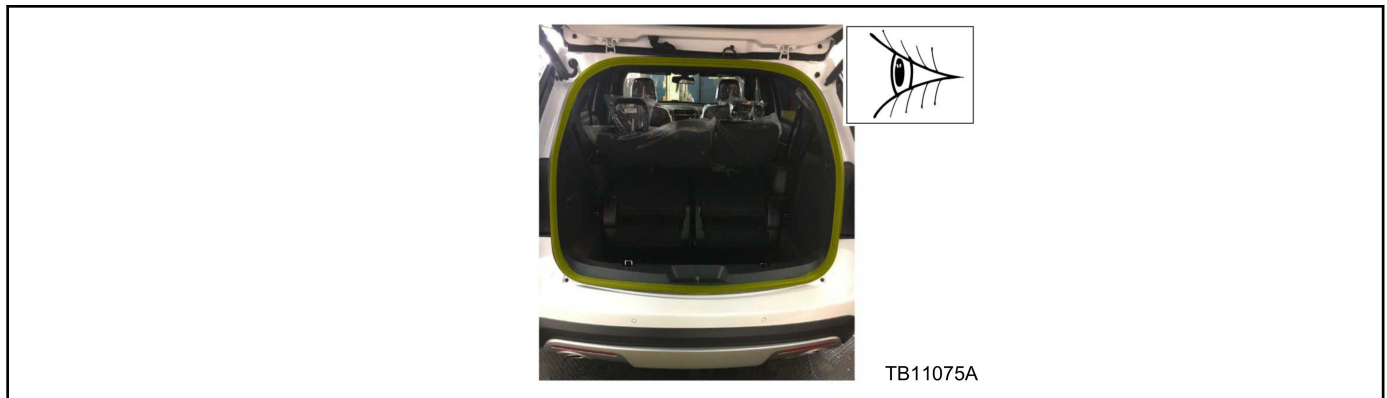
Figure 7 - Article 17-0044

- a. Check for a seal contact mark around the entire liftgate sealing surface. View the weatherstrip contact mark from different angles to make sure that it can be seen clearly. The appearance of a slight gap at the bottom center of the liftgate near the latch area is normal and corresponds with the weatherstrip joint seam. Refer to Workshop Manual (WSM), Section 501-03 to reposition the liftgate as required to obtain a proper seal. (Figure 7)

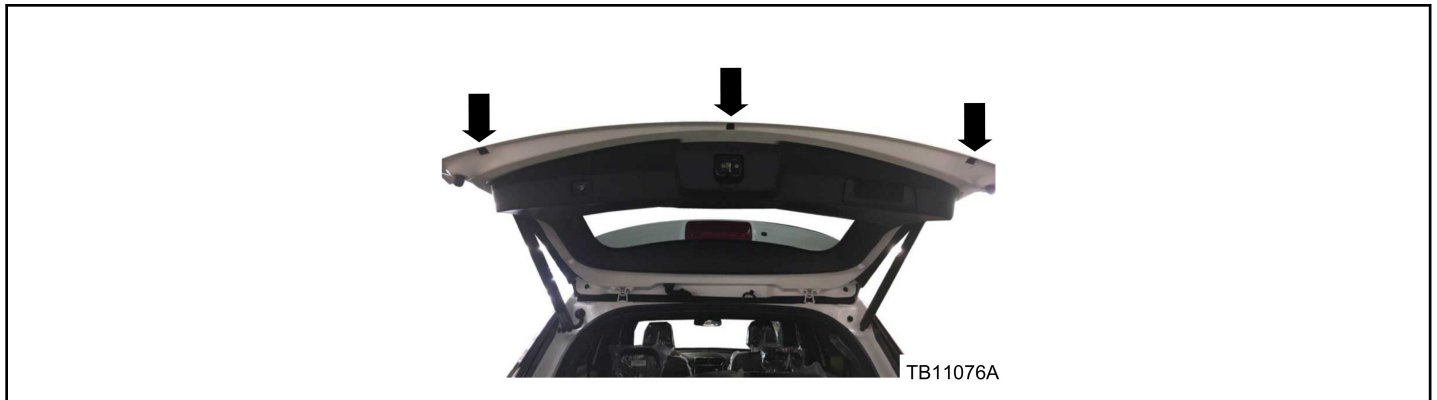
Figure 8 - Article 17-0044

3. Make sure the three (3) liftgate drain plugs are in place and installed correctly on the liftgate. (Figure 8)

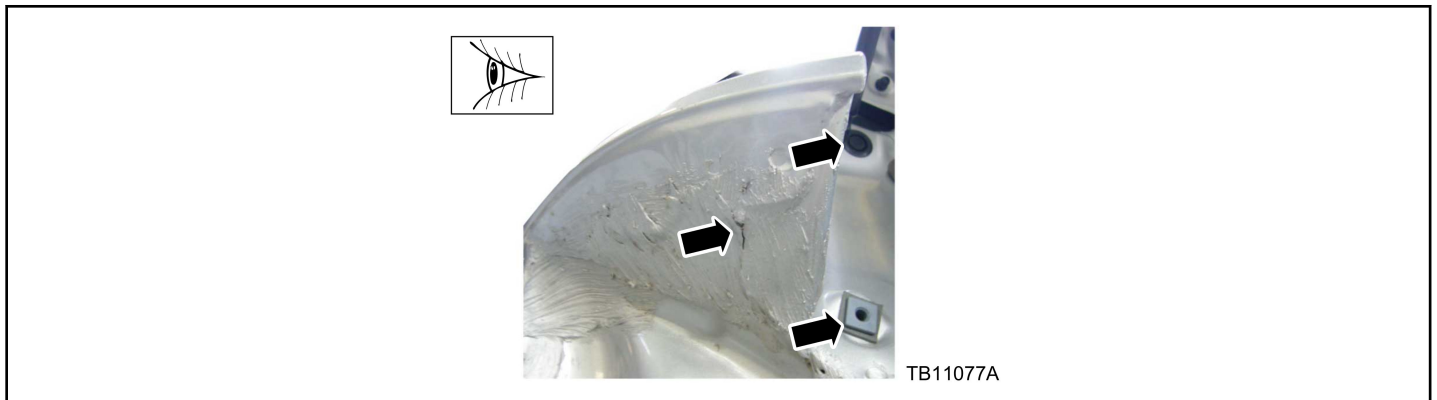
Figure 9 - Article 17-0044

- a. Reposition any incorrectly installed drain plugs.
4. Remove the left and right rear lamp assemblies. Refer to WSM, Section 417-01.
5. Inspect the horizontal and vertical surfaces of the rear lamp mounting area for holes in the body sealer. Verify all body plugs and plastic anchor nuts are properly installed. (Figure 9)

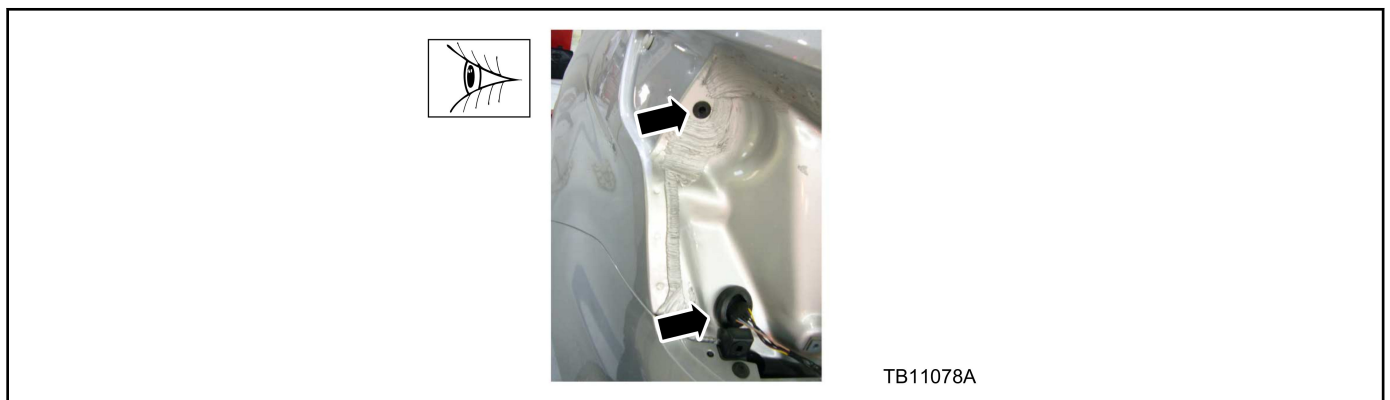
Figure 10 - Article 17-0044

6. Verify all rear lamp mounting and wiring harness grommets are sitting flush against the body.
  - a. Inspect for excess body sealer beneath the grommet preventing it from fully seating thereby creating a leak. (Figure 10)

- b. Remove any excess body sealer and seal the grommet.
7. Remove the right and left rear quarter panel mouldings. Refer to WSM, Section 501-08.

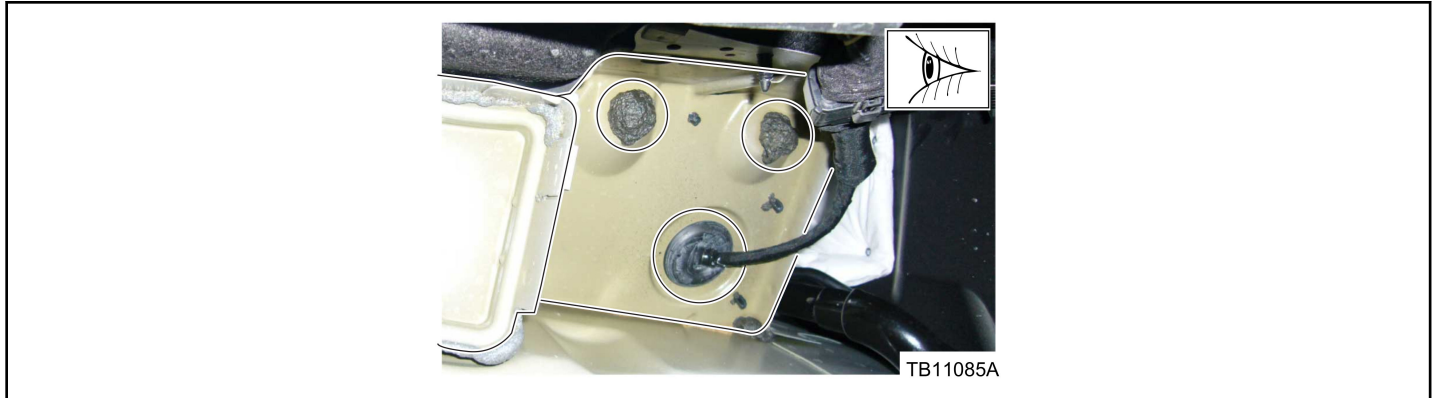
Figure 17 - Article 17-0044

15. Inspect the seams of all joined panels at the rear underside of the vehicle for any gaps or missing seam sealer. (Figure 17)

- a. If any gap and/or missing body sealer is present, enough that may allow air to pass through, seal with Motorcraft® Seam Sealer or equivalent.

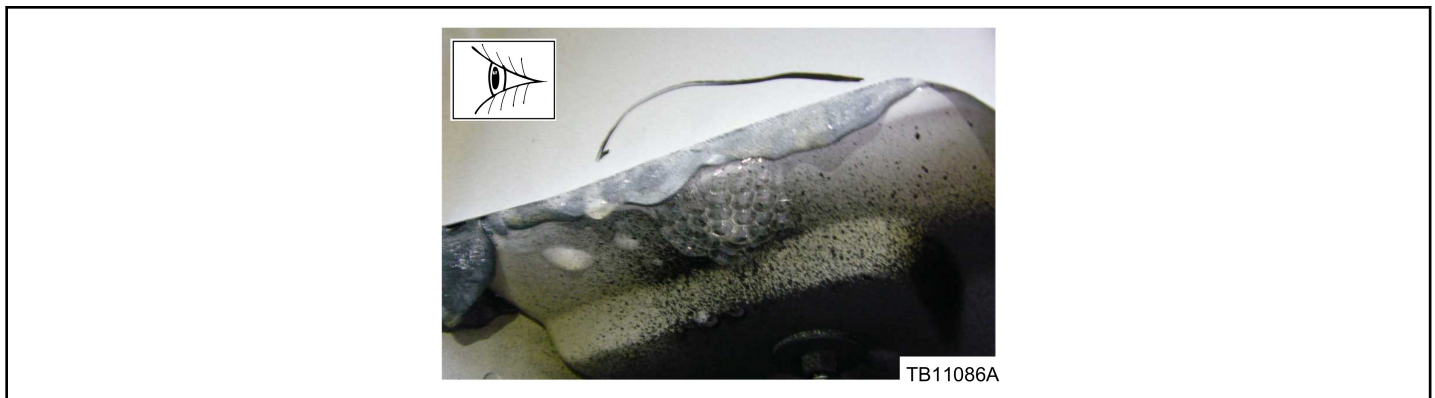
Figure 18 - Article 17-0044

16. Inspect the area behind the wheel arch and reseal if necessary. (Figure 18)

- a. A leak in this area may only show up during a cabin pressurization test.

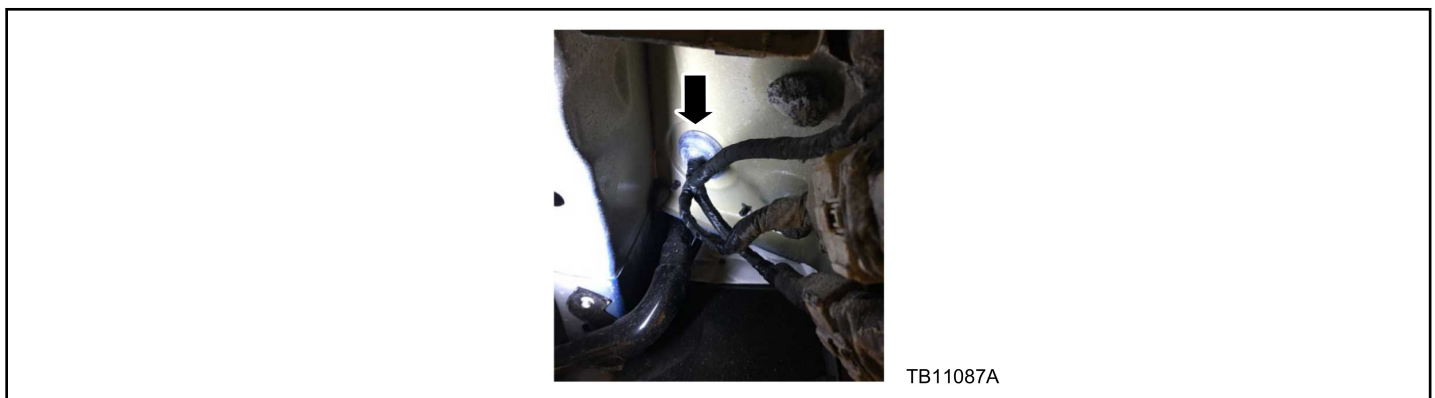
Figure 19 - Article 17-0044

17. Locate the wiring/grommet in the right rear floor area (Figure 19)

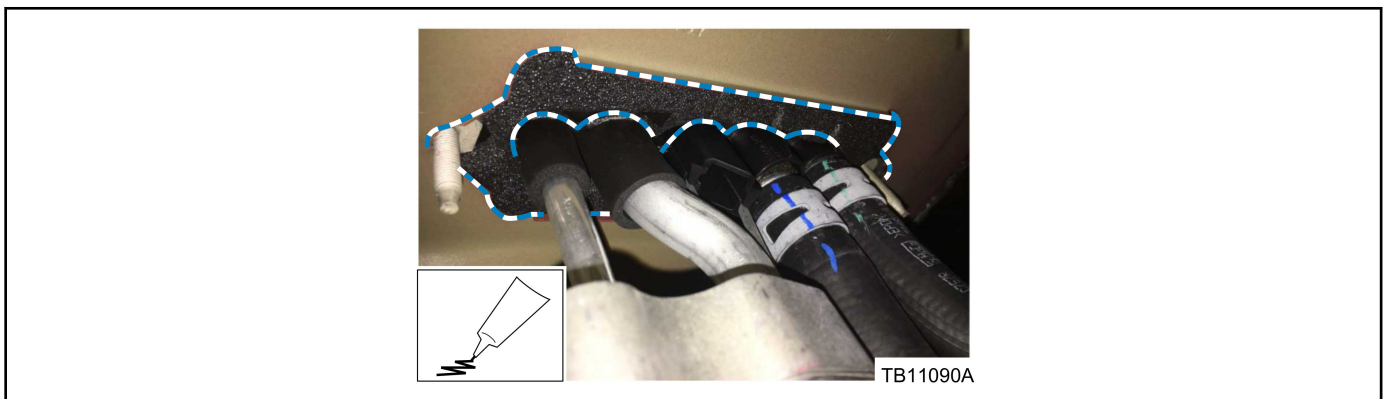
Figure 22 - Article 17-0044

18. Inspect the rear evaporator inlet line seal where the evaporator lines enter the vehicle. Make sure the foam seal is undamaged and fully seated with no gaps between the seal and the body and the seal and the evaporator pipes.
  - a. Rear evaporator inlet line seal viewed from underneath . Inspect for gaps and seal if needed with Motorcraft® Seam Sealer. (Figure 22)

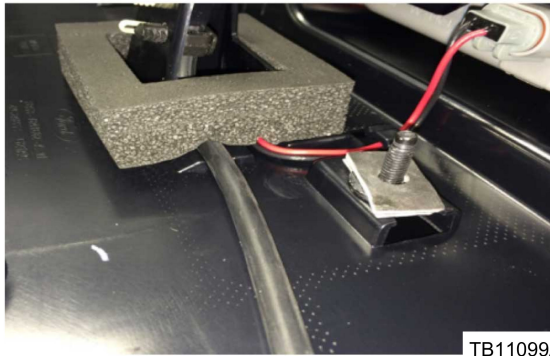
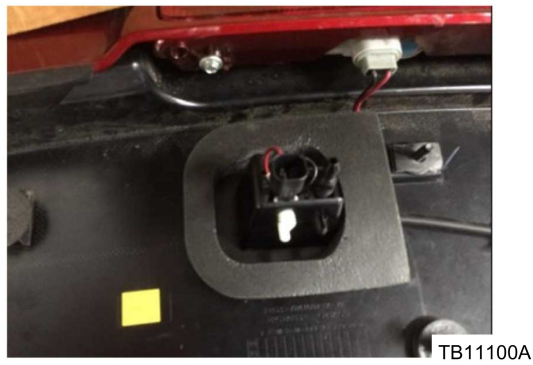
21. Remove the rear spoiler. Refer WSM, Section 501-08.
22. Inspect the foam tower seal and make sure the wiring and washer line are routed properly and are not compromising the sealing interface. There are two designs of the tower foam. Both designs are acceptable to use. (Figures 29-30)

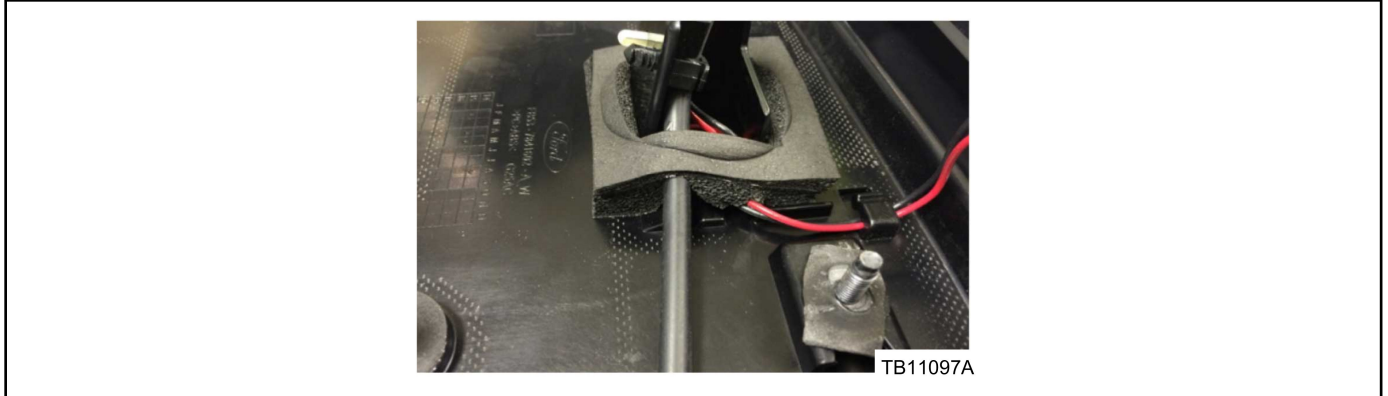
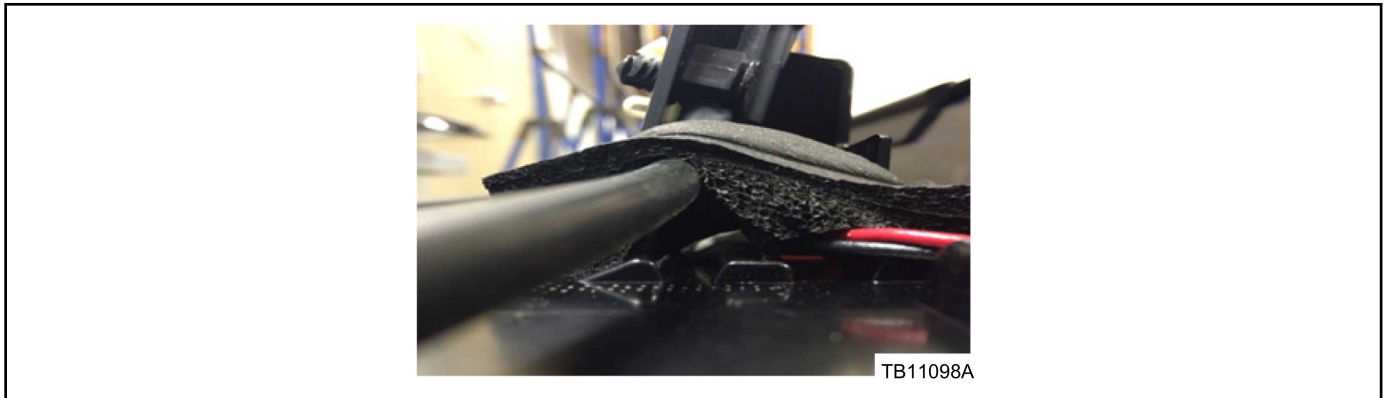
- a. Washer line routed improperly. Line is not seated between locating tabs and sealing foam highly compressed. (Figures 31-32)

- b. Washer line routed properly. Line is seated in locating tabs and sealing foam relaxed. (Figure 29)
  - c. Repair and reseal as necessary using Motorcraft® Seam Sealer or equivalent
- 23. Replace the plastic spoiler retention w-clips with the clips and foam washers from the spoiler service kit.
  - 24. Inspect the liftgate sheet metal for distortion at the 4 clip locations and flatten with a rubber mallet as needed. Reinstall the spoiler. Refer to WSM, Section 501-08.
  - 25. Pressure test the cabin for any additional leaks.
    - a. Before beginning the pressurization process, allow all recently sealed areas to dry for 30 minutes.
