**FORD:**

2012-2013 Focus

**ISSUE**

Some 2012-2013 Focus vehicles built on or before 11/12/2012 may exhibit wet carpet on the passenger side front foot well. This is likely due to leaking climate control condensate.

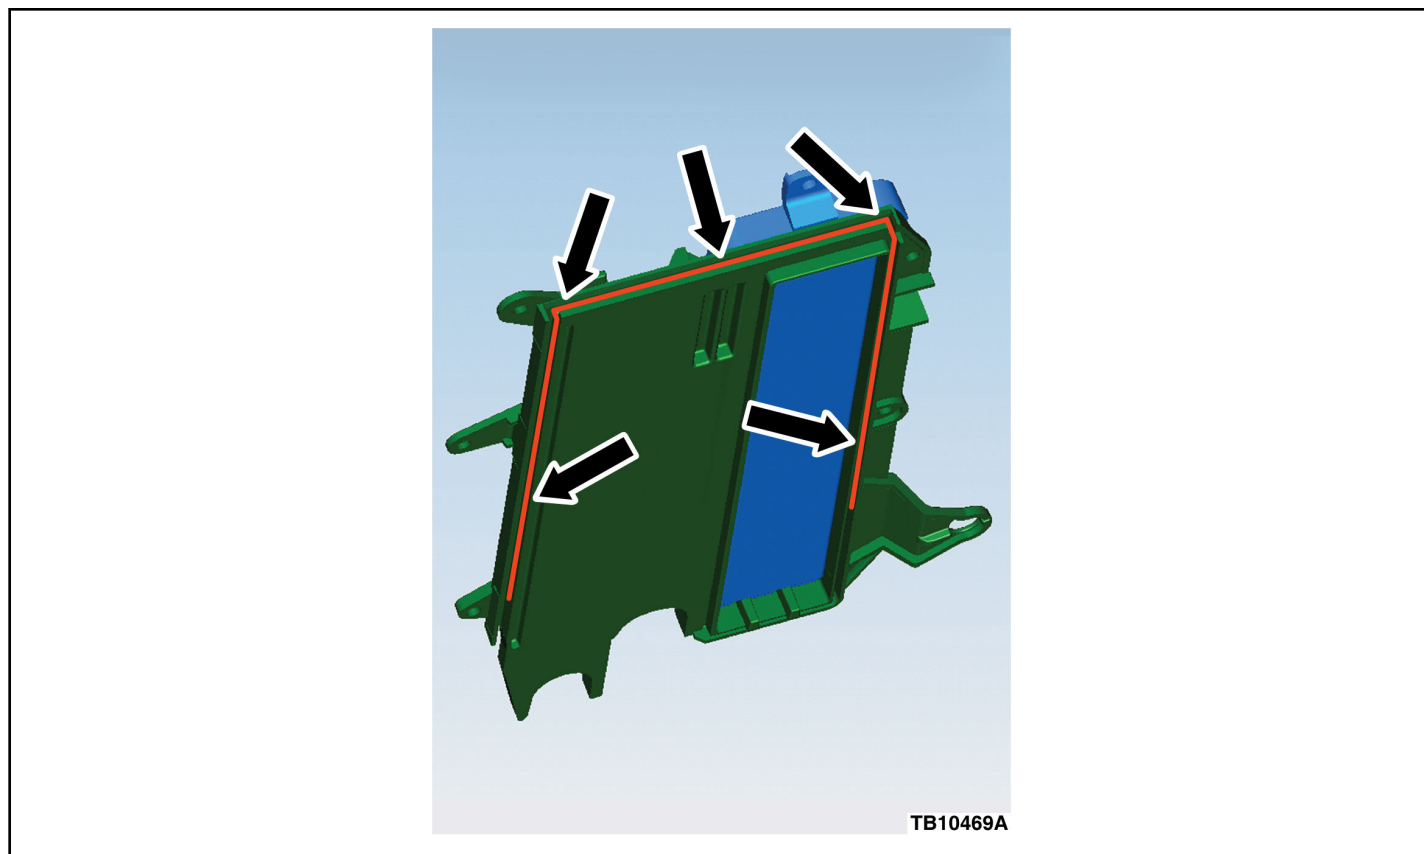
Figure 2 - Article 13-12-6

- a. Stretching the rope seal may result in a water and/or air leak.
- 8. Wrap the rope seal around the corners and continue working into the groove.
- 9. Install the evaporator core access cover.

7. Place the rope seal across the bottom of the evaporator core access cover groove and starting in the middle push rope seal into the groove. (Figure 2)
