- **DRIVEABILITY—SURGE/ROLLING IDLE—GEAR DRIVEN SYNCHRONIZERS—INCORRECT INSTALLATION—CAMSHAFT POSITION SYNCHRONIZER (CMP) INSTALLATION TOOL CORRECT APPLICATION**
- **ENGINE—GEAR DRIVEN SYNCHRONIZERS—INCORRECT INSTALLATION—CAMSHAFT POSITION SYNCHRONIZER (CMP) INSTALLATION TOOL CORRECT APPLICATION**

**Article No.
02-22-1**

FORD: 1994-1997 THUNDERBIRD
1995-2003 TAURUS
1996-2003 MUSTANG
1995-1997 AEROSTAR
1995-2003 RANGER, WINDSTAR
1996-2000 EXPLORER
1997-2003 E SERIES, F-150

MERCURY: 1994-1997 COUGAR
1995-2003 SABLE
1997-2000 MOUNTAINEER

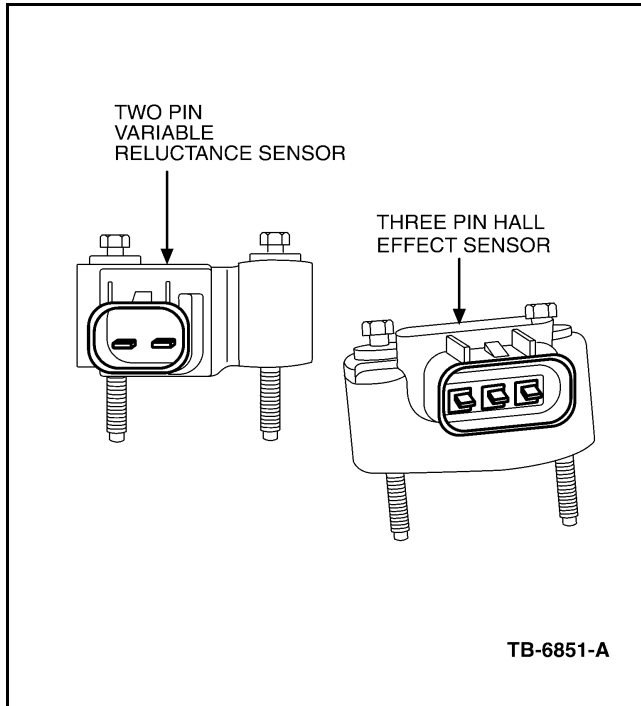
Figure 1 - Article 02-22-1

- The three- pin, Hall-effect sensor (Figure 1)
- The two-pin Variable Reluctance sensor (Figure 1)

Although the Hall-effect (three-pin) and the Variable Reluctance (two-pin) CMP sensors perform the same function, their signal appearance is quite different and they are not interchangeable.

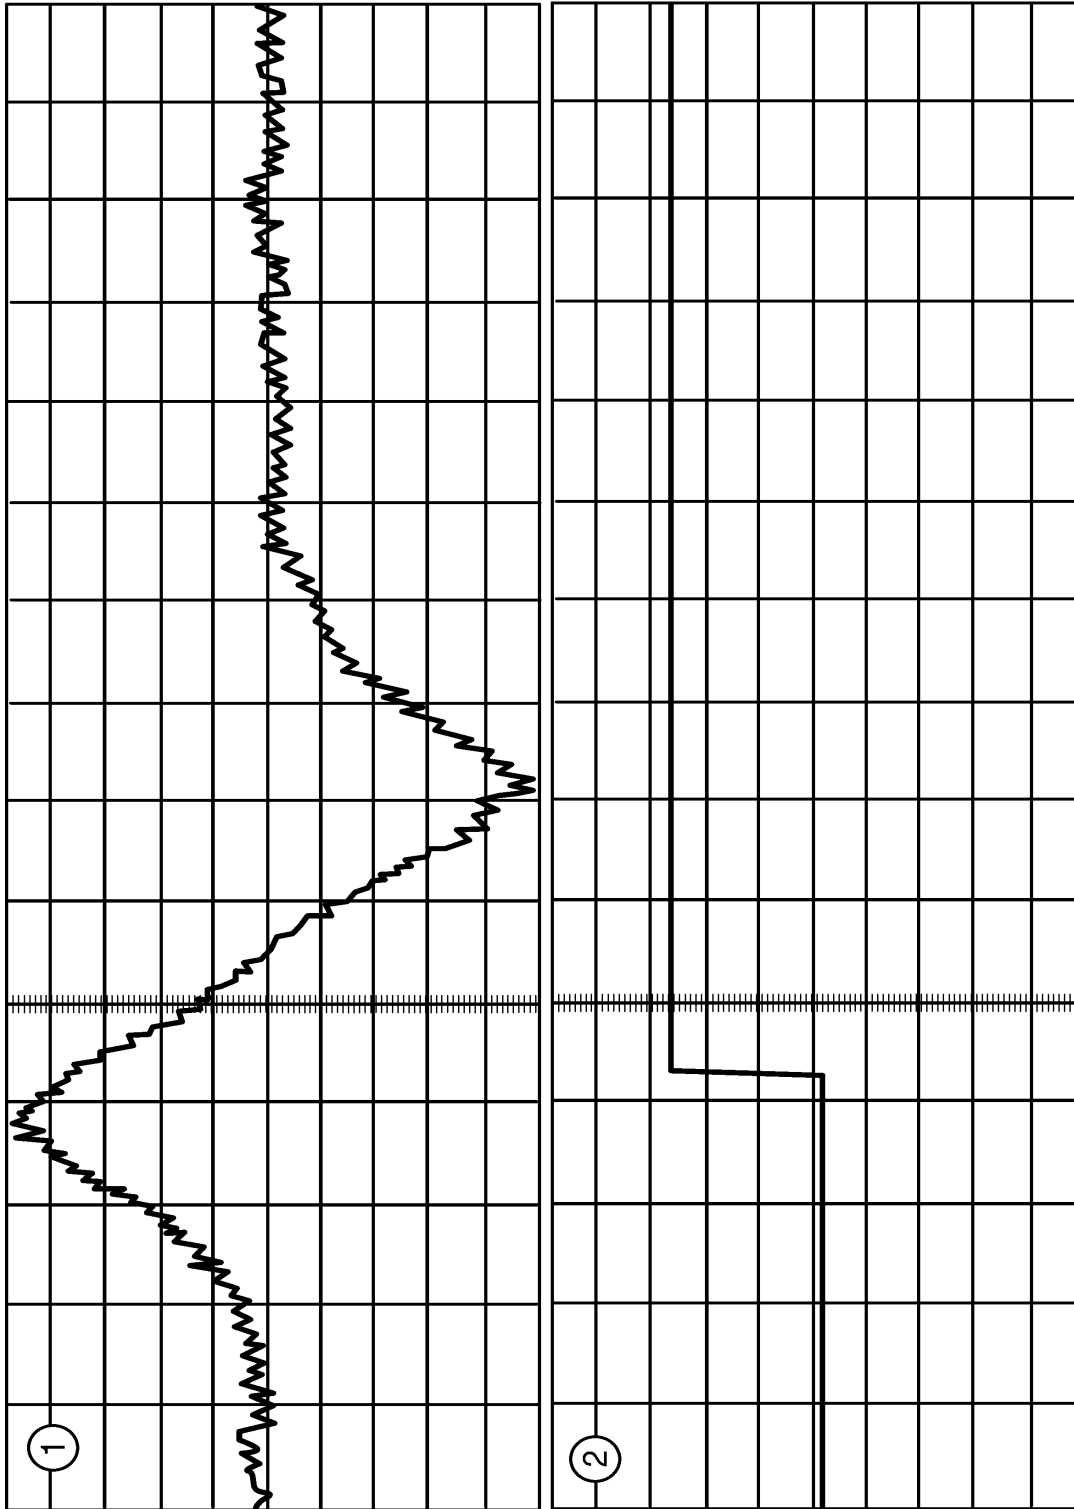
Figure 2 - Article 02-22-1

- The three-pin Hall-effect sensor uses a Hall effect device and a magnet to generate a digital square wave signal (Figure 2)
- The two-pin Variable Reluctance sensor is a magnetic transducer, which uses differential voltage across windings to generate a voltage waveform that is similar to a sine wave (Figure 2)

CMP SIGNALS AS DISPLAYED IN THE WDS OSCILLOSCOPE MODE

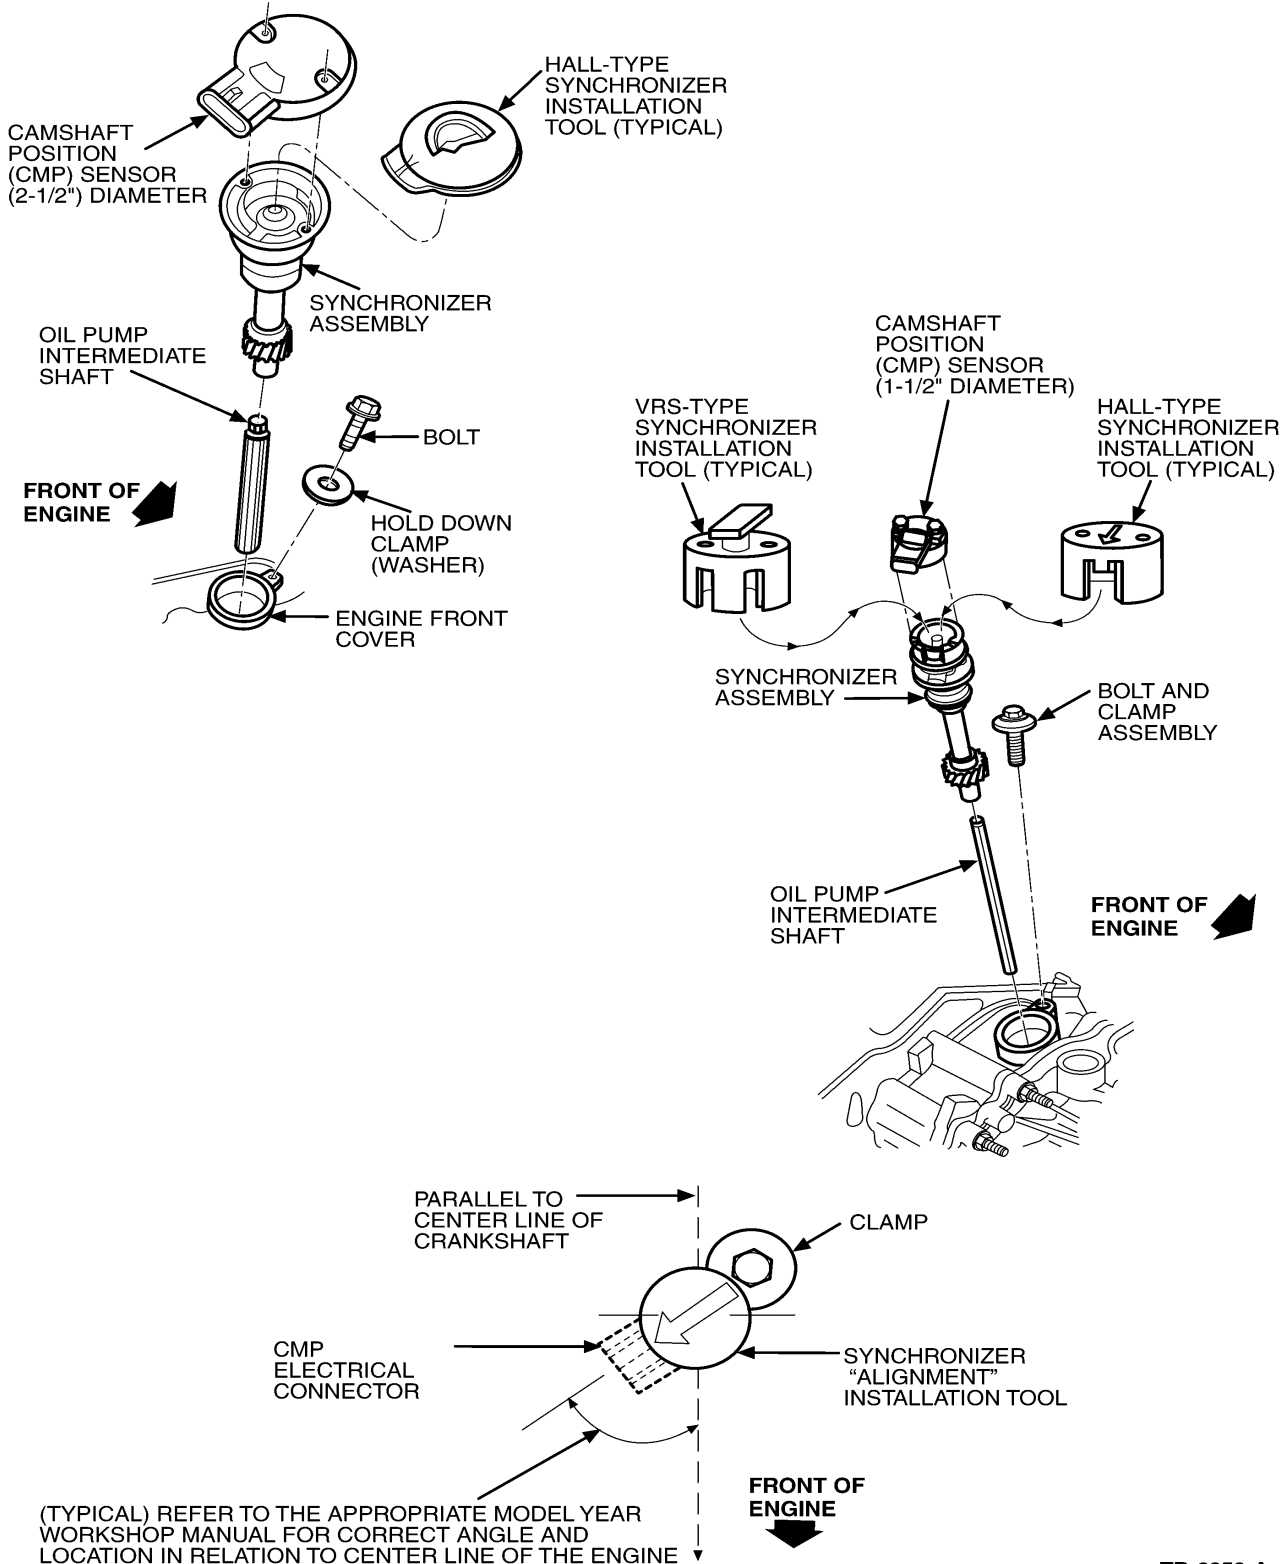
Figure 3 - Article 02-22-1

If you suspect that a vehicle (engine) may have had the synchronizer assembly (Figure 3) installed incorrectly, check the vehicle history to see if related service has been performed. If you determine that the synchronizer could have been installed incorrectly, use the following procedure with WDS to verify correct installation (Figure 5).

ILLUSTRATIONS OF THE GEAR-DRIVEN CMP SYNCHRONIZER ASSEMBLY INSTALLATION

8. Install the camshaft synchronizer assembly so the arrow on the installation tool (Figure 3) is in the correct position as specified in the appropriate model year vehicle and engine. (Refer to Workshop Manual Section 303-14, Synchronizer-Camshaft).
9. Install the synchronizer clamp (bolt) before removing the installation tool. Tighten to 18 Lb-ft (25 N•m).
10. Remove the installation tool.
11. Install the CMP sensor. Tighten to 27 Lb-in (3 N•m).
12. Install battery ground cable.

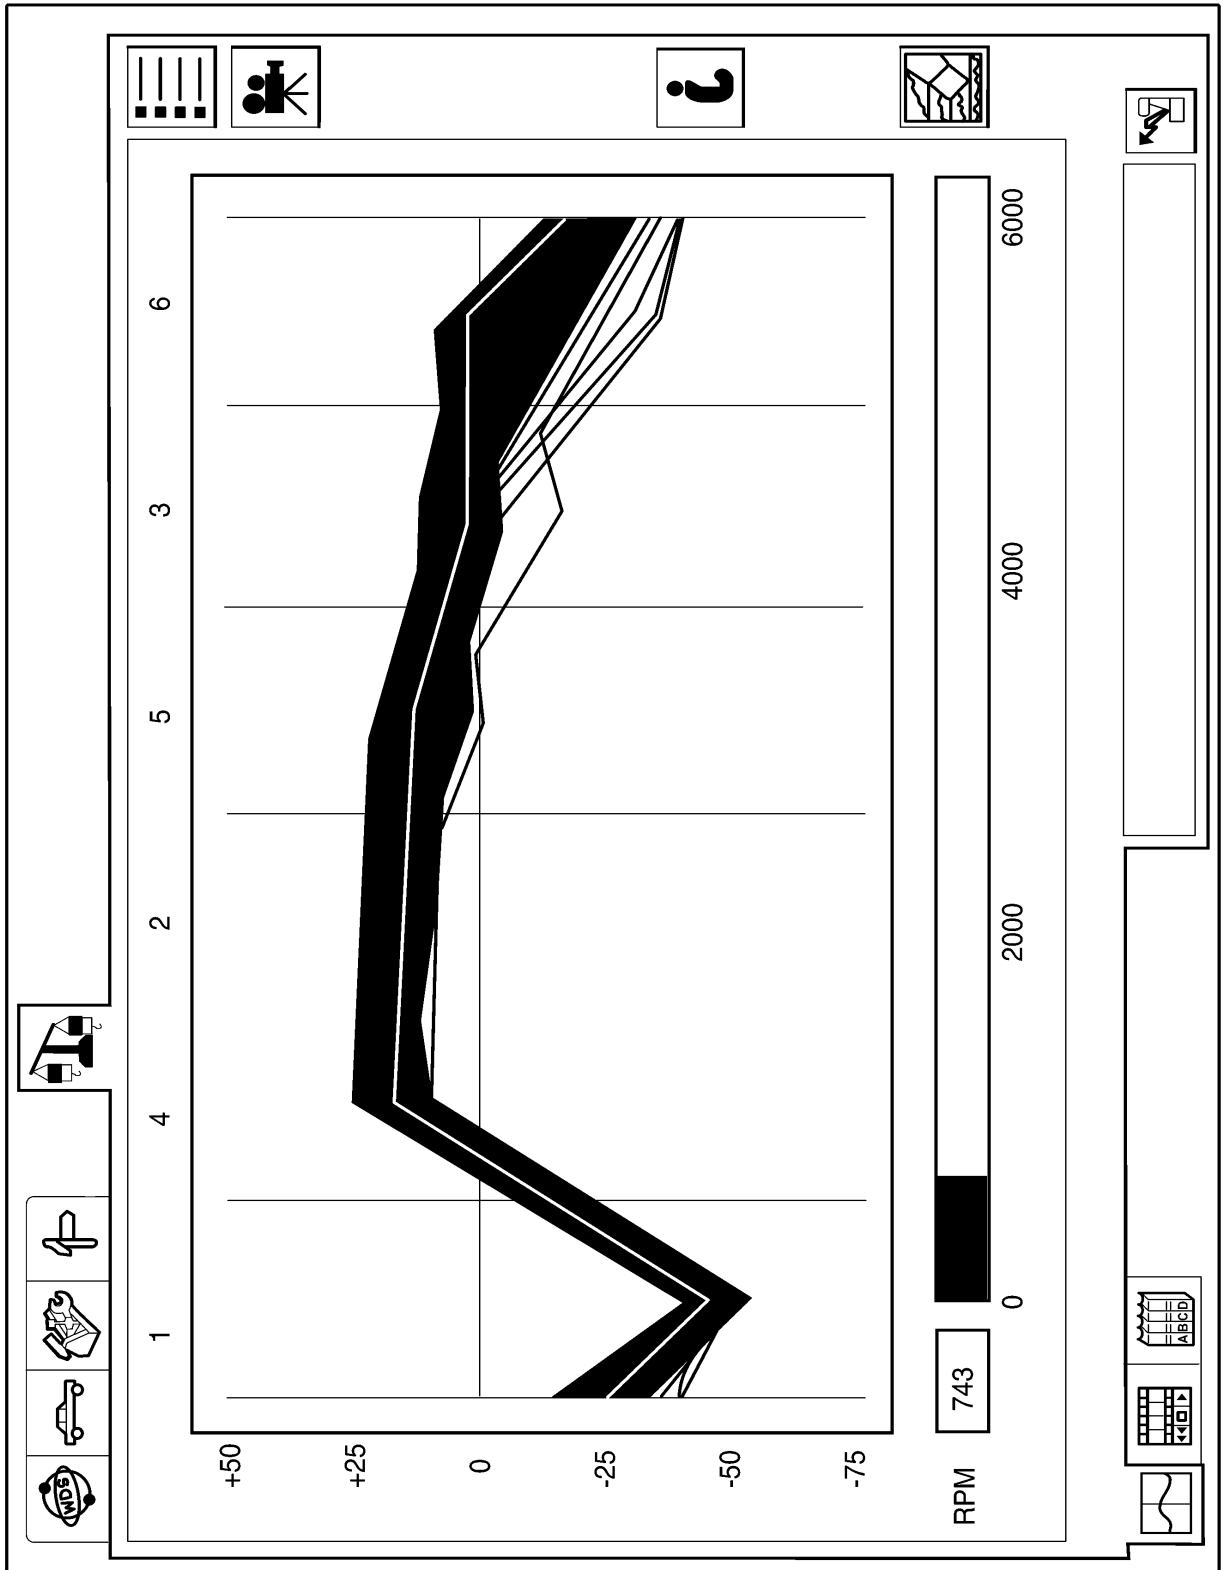
Figure 4 - Article 02-22-1

4. The test should indicate a power loss in the # 1 cylinder (Figure 4).
 - If the # 1 cylinder is indicated, then the CMP synchronizer assembly IS NOT grossly mis-installed. (Figure 4) Continue to Step 5 in this procedure

- If any other cylinder is indicated during the power balance test, then the CMP synchronizer assembly HAS BEEN INSTALLED INCORRECTLY, and must be reinstalled. (Refer to the installation procedure, tool chart and TDC reference described in this TSB, or refer to the appropriate model year Workshop Manual Section 303-14, Synchronizer-Camshaft).

WDS SCREEN SHOWING POWER LOSS IN # 1 CYLINDER

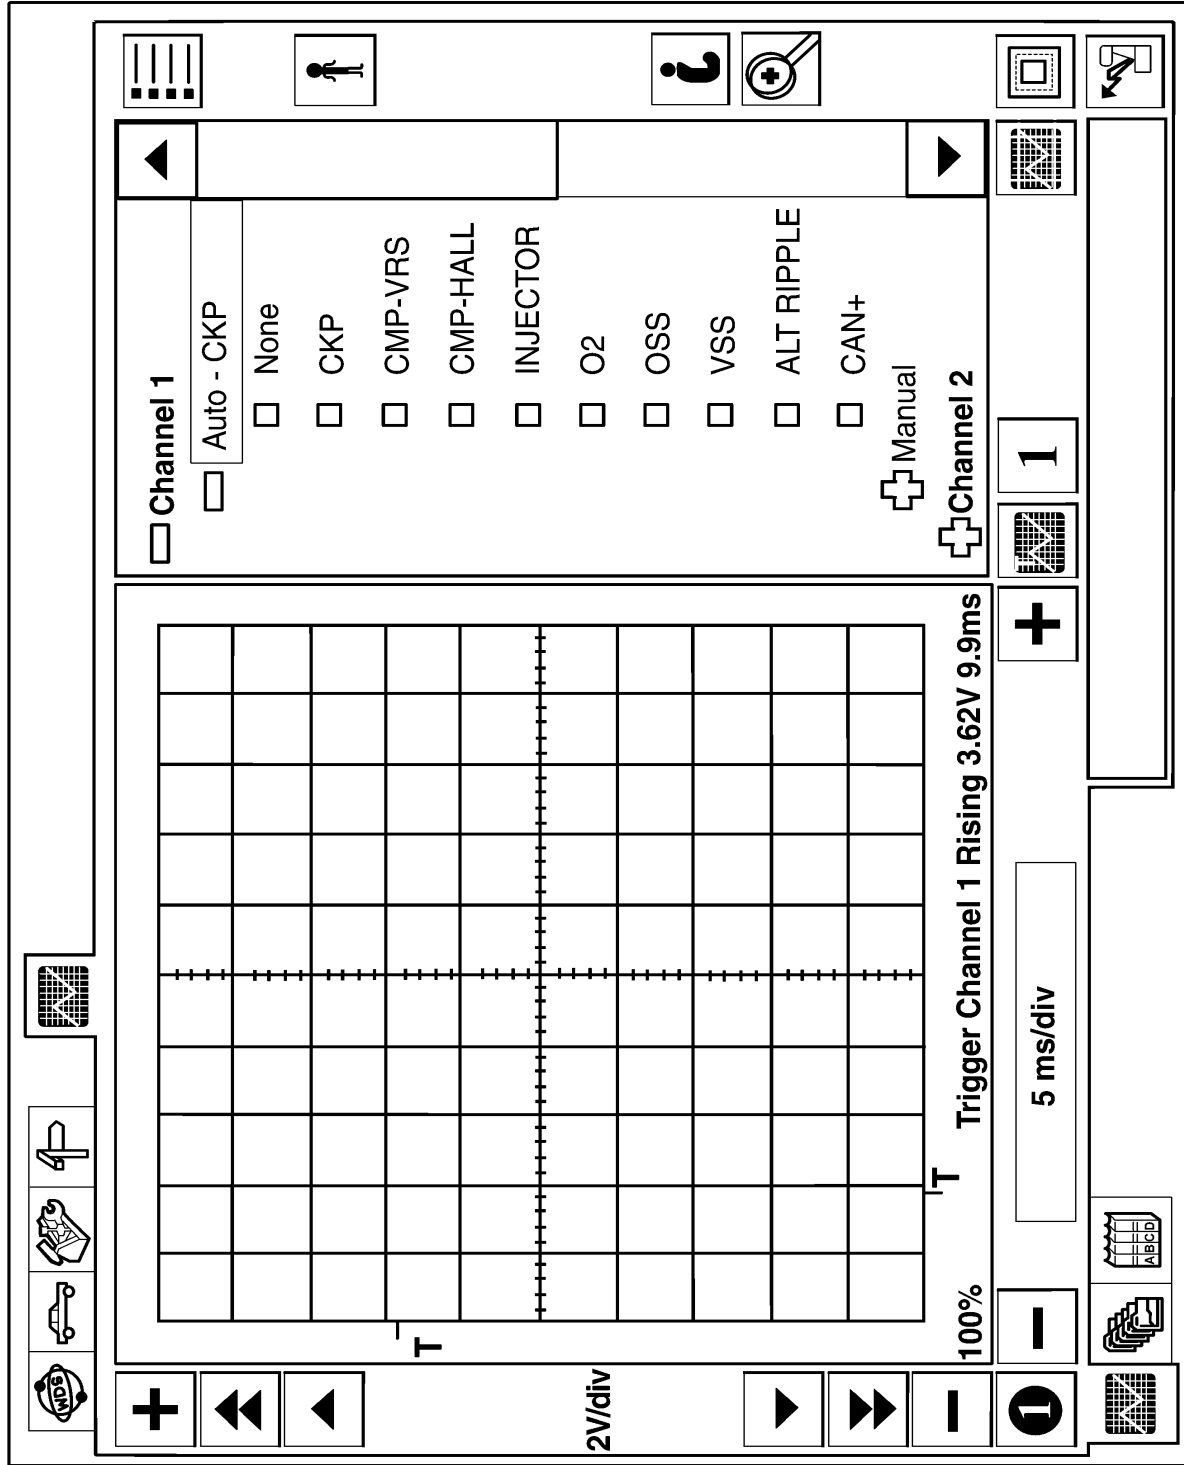
Figure 5 - Article 02-22-1

WDS SCREEN SHOWING CKP AND CMP SELECTION IN AUTO MODE

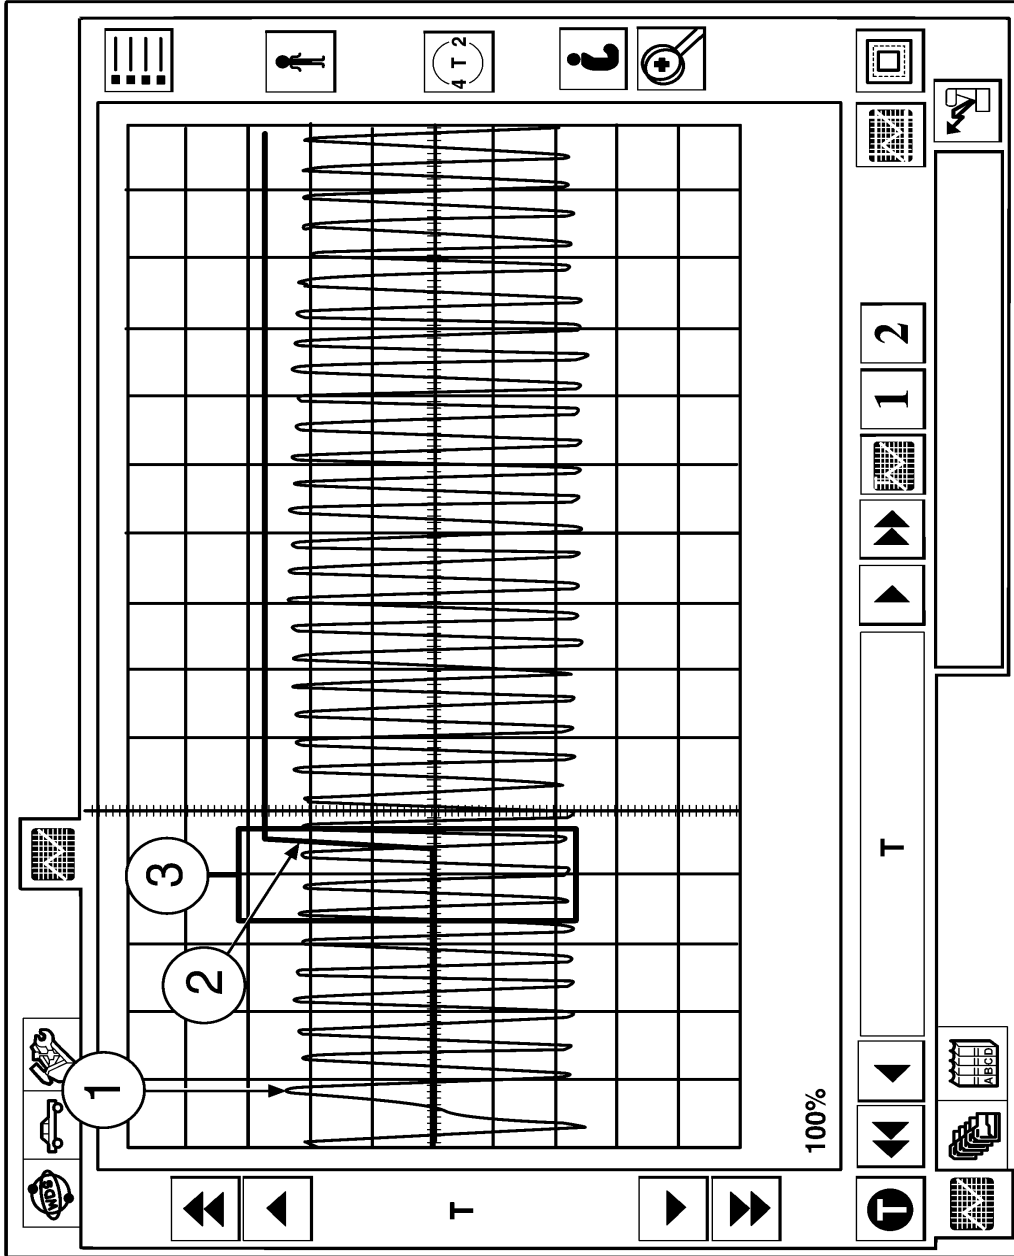
Figure 6 - Article 02-22-1

On all Hall-effect sensors, the CMP wave form rising edge should occur between the 7th and the 10th peak past the missing tooth. (Figure 6)

WDS SCREEN SHOWING KNOWN GOOD CKP/CMP (3-PIN, HALL EFFECT) WAVE FORMS

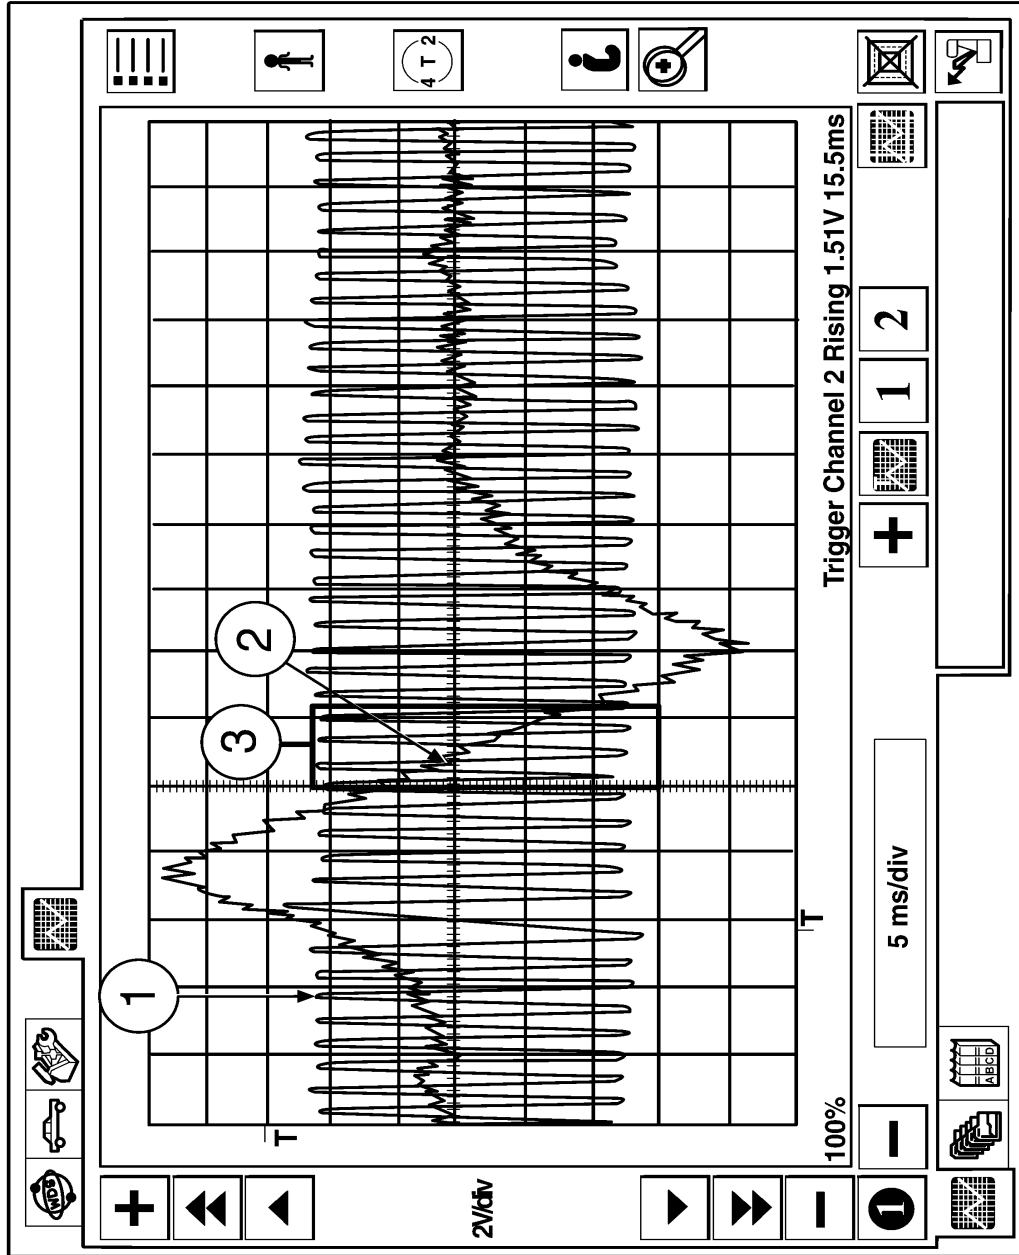
Figure 8 - Article 02-22-1

On 5.0L engines with a VRS CMP sensor, the falling edge waveform should cross the zero reference line between the 6th and the 9th peak past the CKP missing tooth (Figure 8).

WDS SCREEN SHOWING KNOWN GOOD CKP/CMP 5.0L ENGINE (2-PIN, VRS) WAVE FORMS
