# **MALFUNCTION INDICATOR LAMP (MIL) WITH DIAGNOSTIC TROUBLE CODES (DTCs) P1285, P1299, P0128, P0301, P0302, P0303, P0304, P0316**

**TSB 11-10-5**

2010-2012 Fusion, Escape, Transit Connect

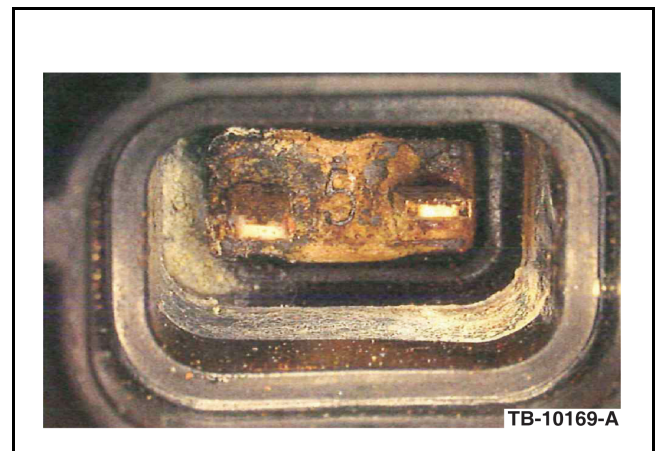
Figure 1 - Article 11-10-5

**Engine temperature concerns may be due to corrosion at connector C1164.**

3. If corrosion from water contamination is severe and terminals are rusted and disintegrated: (Figure 1)

- a. Cut off connector C1164 and install a new pigtail connector. Refer to instruction sheet.
  - b. Replace the CHT sensor. Refer to Workshop Manual (WSM), Section 303-14. Proceed to Step 4.
4. If corrosion is not severe, remove any water and thoroughly clean connector C1164 and the CHT sensor.
  5. Before reattaching the CHT sensor cover to the cam cover, clean the cam cover and CHT sensor cover with Motorcraft® Metal Brake Parts Cleaner.
