**FORD:**

2010-2011 Fusion  
2009-2011 Escape

This article supersedes TSB 11-11-18 to update the Service Procedure and Part List.

## TSB 11-12-5 (Continued)

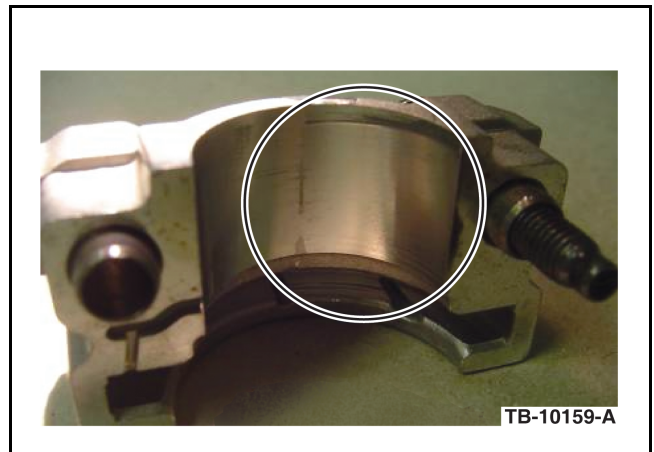
Figure 1 - Article 11-12-5

1. Verify engine build date. Refer to Workshop Manual (WSM), Section 303-01B.
  - a. If the engine built date is after 3/1/2011, do not continue with this procedure. Refer to the Powertrain Control/Emissions Diagnosis (PC/ED) Manual for normal diagnostics.
  - b. If the engine built date is on or before 3/1/2011, proceed to Step 2.
2. Remove both valve covers. Refer to WSM, Section 303-01B.
3. Remove both front intake and both front exhaust camshaft thrust bearing caps. Refer to WSM, Section 303-01B.
  - a. If the camshaft thrust bearing cap(s) shows surface wear, proceed to Step 4. (Figures 1-2)

- (1) Wear in the thrust bearing cap could be the cause of the variable camshaft timing (VCT) setting DTCs due to oil leakage from excessive clearance in the cam bearing cap. This in turn will not allow enough oil to feed the VCT phaser for proper operation.

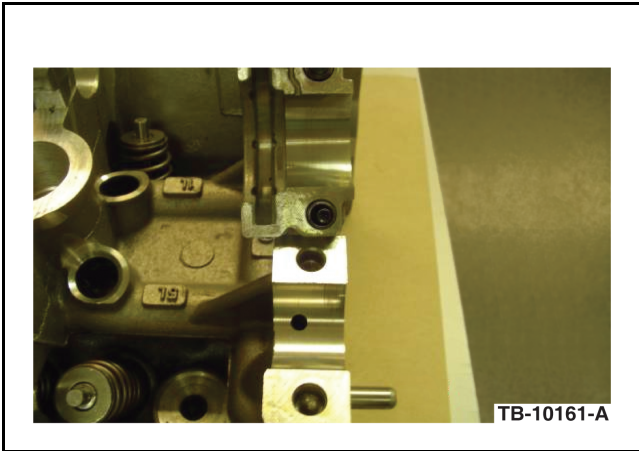
Figure 3 - Article 11-12-5

- b. If the camshaft thrust bearing cap(s) does not exhibit any abnormal wear, re-assemble cap(s) to cylinder head, torque to 10 N•m (7.5 lb-ft) and proceed to Step 5. (Figure 3)

- (1) Slight polishing is normal and is not reason to replace the cylinder head. (Figure 3)
4. Inspect the camshaft that is under the effected worn cam thrust bearing journal for wear.
  - a. If the cylinder head only shows wear, replace the cylinder head(s) of the affected cap(s). Refer to WSM, Section 303-01B. (Figures 1-2)
  - b. If both the cylinder head and camshaft show wear. Replace cylinder head(s) and cam shaft(s) of the affected cap(s). Refer to WSM, Section 303-01B.
5. Replace both VCT solenoids. Refer to WSM, Section 303-14B.
  - a. If the vehicle has less than 48,000 km (30,000 miles), the intake gasket and spark plug well gaskets can be reused. Inspect and replace only if damage is visible.
  - b. If the vehicle has 48,000 km (30,000 miles) or more, replace the intake and spark plug well gaskets. In all cases, the valve cover perimeter gasket must be replaced.
