# CLIMATE CONTROL—ERRATIC OPERATION OF THE COOL/WARM FUNCTION OF THE TEMPERATURE CONTROL SYSTEM—REPAIR PROCEDURE FOR STRATIFICATION (SECONDARY) TEMPERATURE BLEND DOOR

Article No.  
02-23-6

**FORD:** 1996-2003 TAURUS

**MERCURY:** 1996-2003 SABLE

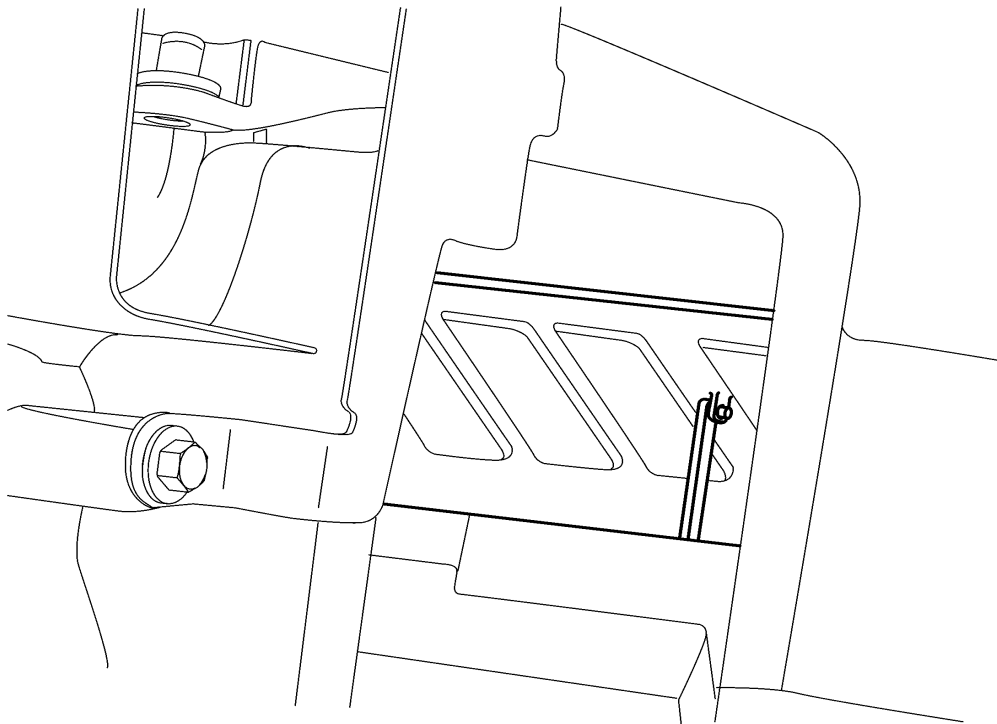
Figure 1 - Article 02-23-6

4. Inside the plenum, you will see the Stratification (Secondary) Temperature Blend Door or upper door attached to the main temperature blend door by an internal white nylon link. Disconnect the nylon link from the stratification door. Squeezing the clips together on the white nylon link should aid in removal (Figure 1).

5. Reach inside and remove the stratification door. Cutting the door with metal snip pliers near the pivots will provide easier removal.
6. Place the new door 3F1Z-19D842-AA inside the plenum chamber and slide in the large pivot point first (which is closest to you) then slide the door into position until the small door pivot point on the front side of the case clicks into place.
