# 6.0L—BUILT ON OR BEFORE 9/29/2003 DTCS P006A, P132B, P0401 OR P0402—LACKS POWER, SURGE, OR FLUTTER AFTER FIELD SERVICE ACTION 06E17

TSB 09-15-6

2003-2004 Excursion, F-Super Duty

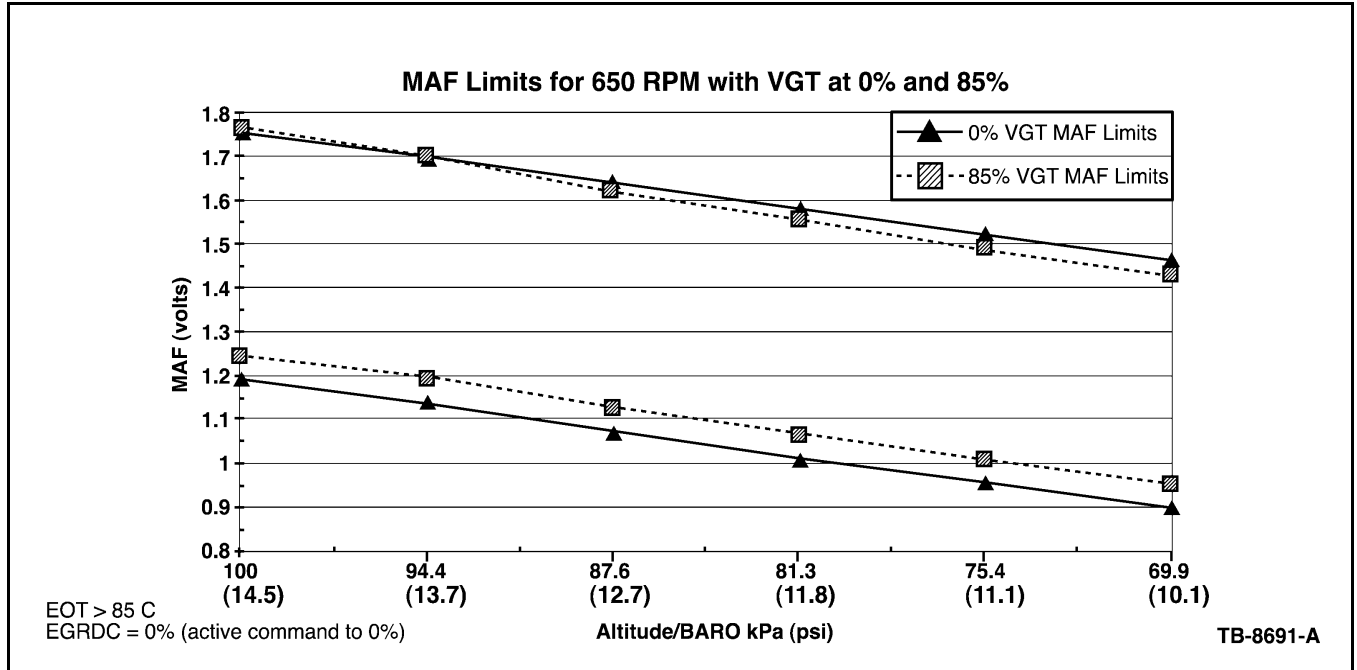
Figure 1 - Article 09-15-6

- c. Compare the voltage to Figures 1 and 2. Reading is outside of MAF limits and/or recorded value is lower than limits, possible causes are:
  - (1) MAF sensor.

- (2) Air leak between MAF sensor and turbo.
  - (3) Aftermarket Air Intake system and/or Air Filter.
  - (4) Leaking EGR O-ring or gasket.
  - (5) Exhaust restriction.

- d. Compare the voltage to Figures 1 and 2. Recorded value is higher than limits, possible causes are:
  - (1) MAF sensor.
  - (2) Air Leak in the charge air cooler (CAC) system.

- (3) Dirty Air Filter.
  - (4) Aftermarket Air Intake System and/or Air Filter.
- e. Verify the MAP/BARO correlation. Are they within 1.5 psi (10.3 kPa) of each other? If not, follow PC/ED PPT test E2 for the appropriate diagnostic and repair.
