SERVICE TIP—POWER TRANSFER UNIT (PTU)— RIGHT HAND INTERMEDIATE SHAFT SEAL LEAKS

TSB 09-25-7

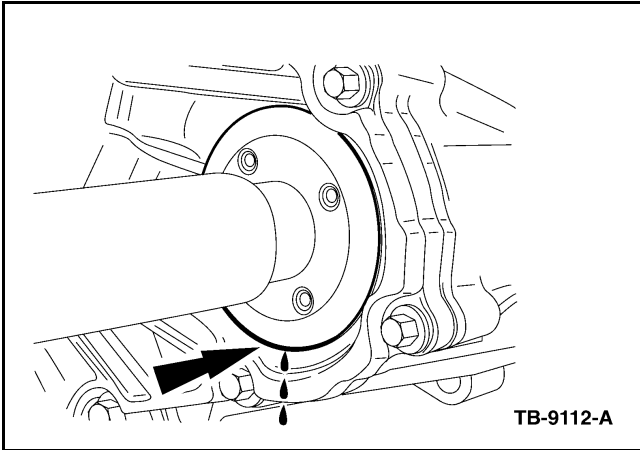
Figure 1 - Article 09-25-7

Red automatic transmission fluid (ATF) is not used in the PTU itself. The RH intermediate shaft passes from the transaxle through the input hub of the PTU, where the intermediate shaft seal is located. A red ATF leak indicates fluid from the transaxle is leaking past this intermediate shaft seal contained in the PTU. Use the seal kit, which contains four pieces: the intermediate shaft seal, alignment washer, deflector, and seal protector tool. The intermediate shaft seal, alignment washer, and deflector need to be installed individually and before the seal protector tool is used.

Brown/Black Fluid Indicates a True PTU Seal Leak

REFER TO (FIGURES 1 AND 2) THAT IDENTIFIES THE LOCATION OF THE PTU LEAKS.

Use the seal kit, which contains five pieces: the PTU cover seal, intermediate shaft seal, alignment washer, deflector and seal protector tool. The intermediate shaft seal, alignment washer, cover seal, and deflector need to be installed individually and before the seal protector tool is used. Use seal kit, which contains the PTU cover seal, intermediate shaft seal, alignment washer, and deflector. All four parts need to be installed individually.

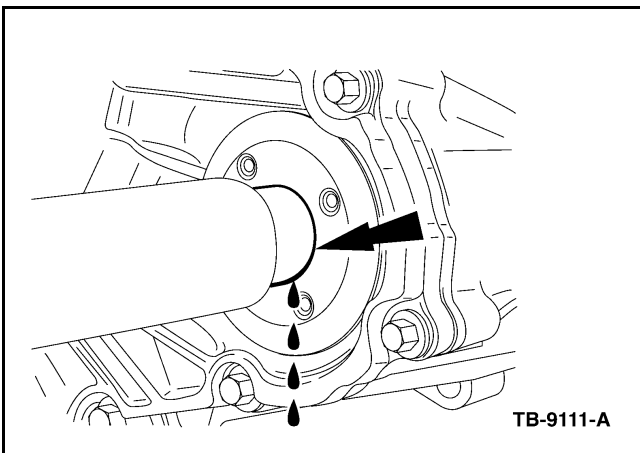
Figure 2 - Article 09-25-7

THE PTU COVER SEAL ONLY NEEDS TO BE REPLACED WHEN THERE IS BROWN/BLACK GEAR LUBE LEAKING FROM BETWEEN THE BOTTOM EDGE OF THE DEFLECTOR AND THE PTU COVER.
