1.6L OR 2.0L GTDI—DRIVABILITY CONCERNS WITH DTCS P0106/P0236/P06A7—OR ENGINE FAULT SERVICE ENGINE NOW MESSAGE WITHOUT DTCS

2013 Escape

TSB 13-7-5 (Continued)

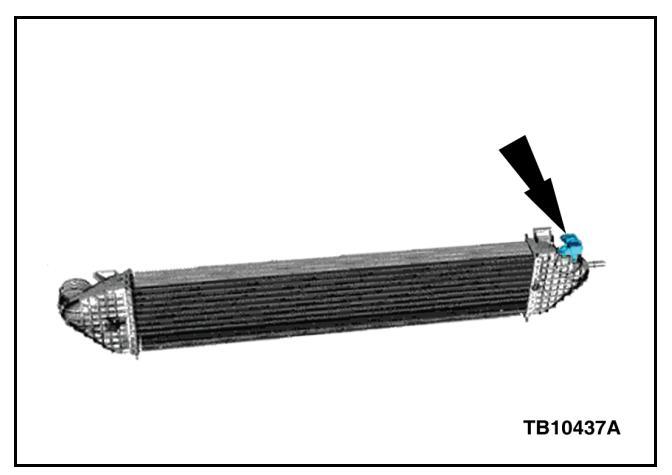
Figure 1 - Article 13-7-5

- 1. Using Integrated Diagnostic System (IDS), check for DTCs.
- 2. Does the vehicle exhibit a drivability concern with DTC P06A7 stored?
 - a. Yes replace TCBP/CACT/MAPT sensor and connector pigtail. Refer to Workshop Manual (WSM), section 303-14, and Wiring Diagram, Section 5-1. (Figures 1 and 2)
 - (1) Other DTCs may be present along with P06A7, which share the VREF circuit.
 - (2) 1.6L GTDI engine TCBP/CACT (MAPT) sensor location. (Figure 1)

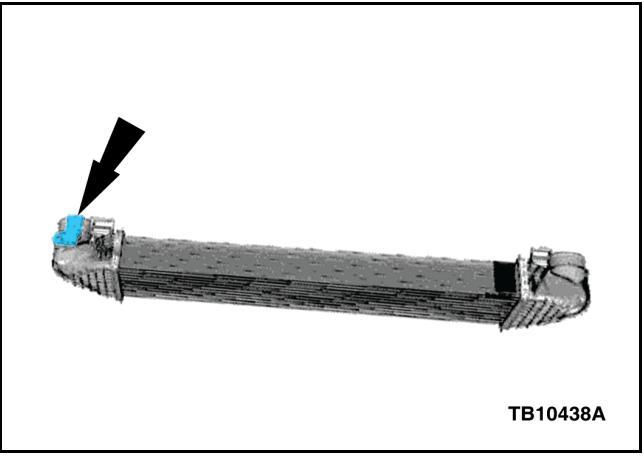
(3) 2.0L GTDI engine TCBP/CACT (MAPT) sensor location. (Figure 2)

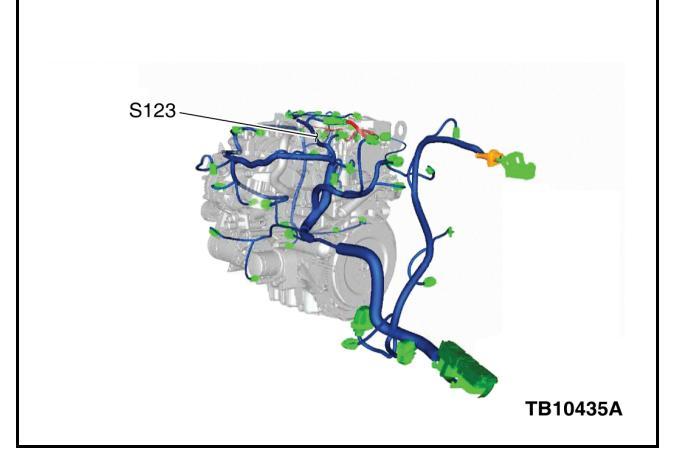
Figure 3 - Article 13-7-5

- a. Yes replace the signal return splice for MAP sensor (DTC P0106) or for TCBP/CACT/MAPT sensor DTC P0236. Refer to Workshop Manual (WSM), section 303-14, and Wiring Diagram, Section 5-1. (Figures 3-5).
 - (1) 1.6L GTDI engine MAP sensor signal return splice location (S123). (Figure 3)

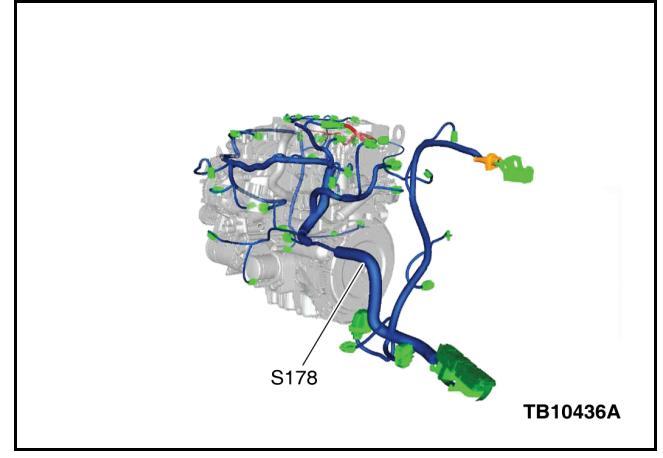
Figure 4 - Article 13-7-5

(2) 1.6L GTDI engine TCBP/CACT signal return splice location (S178). (Figure 4)

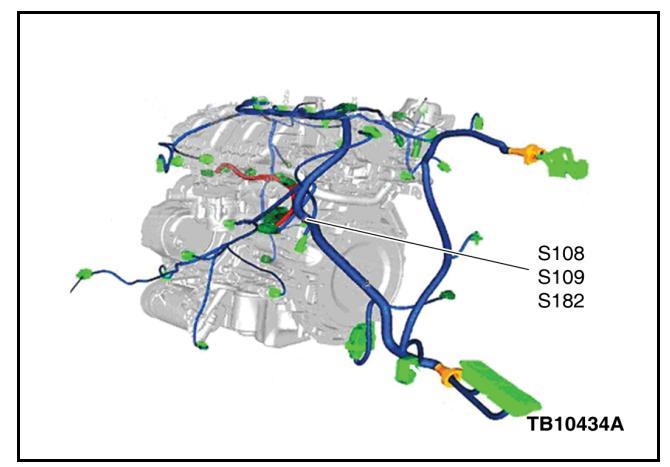
Figure 5 - Article 13-7-5

(3) 2.0L GTDI engine MAP (S108) and TCBP/CACT (S182) signal return splice locations. (Figure 5)

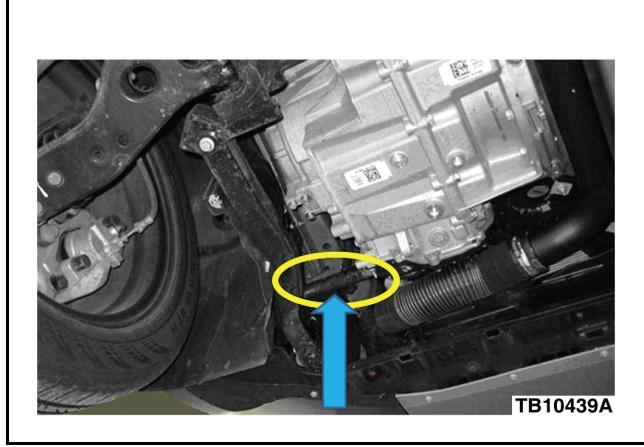
Figure 6 - Article 13-7-5

- Some of the splices have more than just MAP or TCBP/CACT signal return circuits; replace all signal return circuits in these splices.
 - b. 1.6L or 2.0L GTDI engine wiggle test here by pushing and pulling on the harness lightly while monitoring MAP, BARO, TIP_PRS-BOOST at key on engine off (KOEO). (Figure 6)

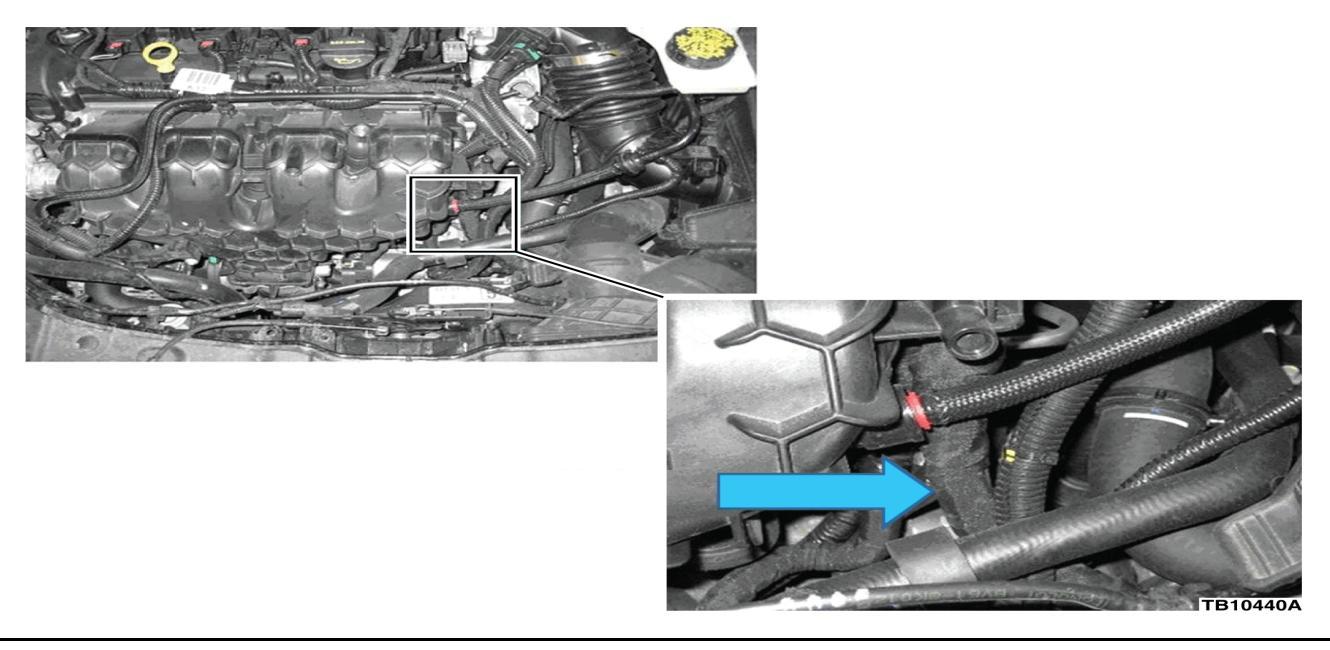
Figure 7 - Article 13-7-5

c. 2.0L GTDI engine wiggle test here by pushing and pulling on the harness lightly while monitoring MAP, BARO, TIP_PRS-BOOST pressure in PSI units at KOEO. (Figure 7)
