| General Service Bulletin (GSB): | Brake Disc Servicing Tips |
| GSB Overview: | This bulletin is a supplement to Workshop Manual (WSM) procedures. The purpose is to assist the dealership technician with determining the correct procedure for warranty repairs. |

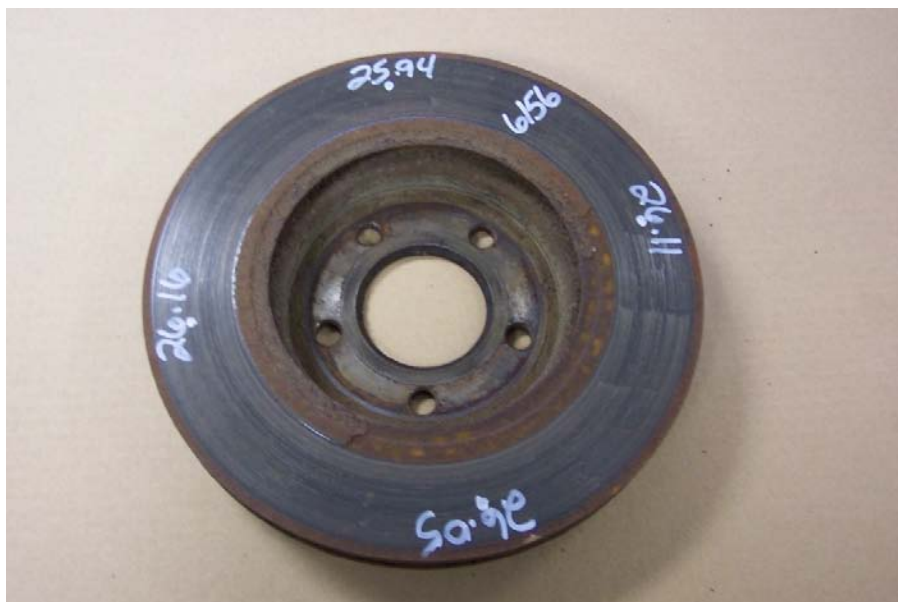
- 1) Follow the Workshop Manual for proper diagnosis and repair.
  - If the disc can not be machined / resurfaced - replace the disc and determine warranty eligibility per the Warranty & Policy Manual.
  - If the disc is to be replaced – you **MUST** also record thickness measurements on the brake disc surface in paint pen or permanent marker (see attached example).

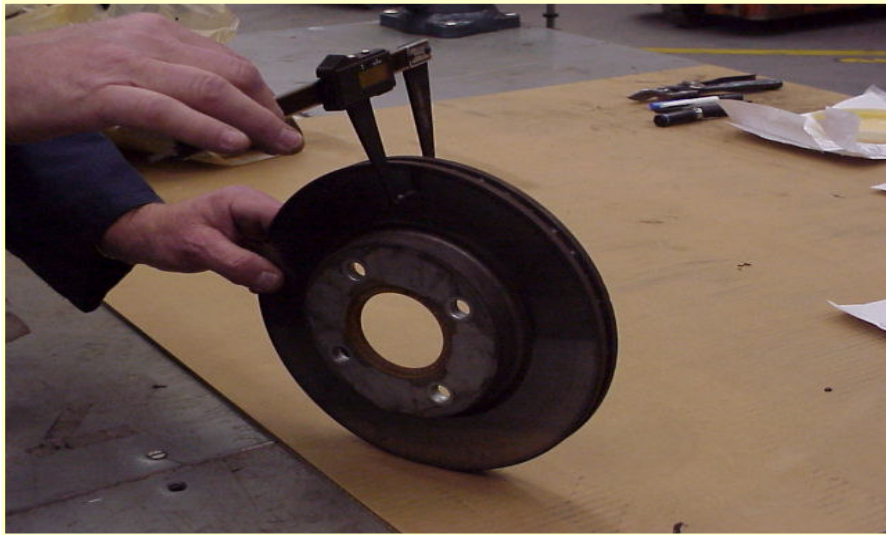
- 2) Using a brake micrometer, measure the brake disc in at least 4 places to determine thickness. Take the measurements 2/3 of the way towards the outer edge of the disc.

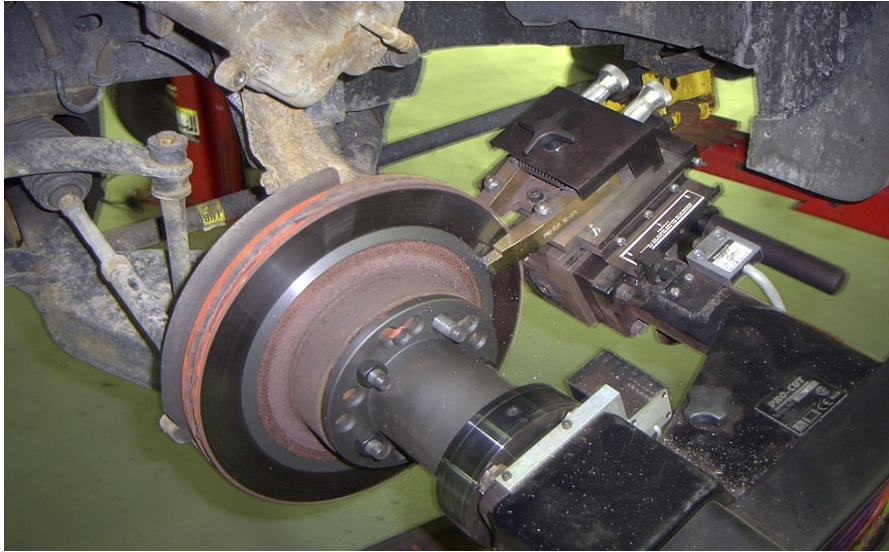
- 3) Check brake disc minimum thickness specification. Refer to Specifications in WSM Section 206-00.
- 4) If the brake disc thickness is greater than the minimum thickness specification and the machining (turning) process will not reduce the thickness below the minimum specification, perform on-vehicle brake disc machining. Refer to General Procedures in WSM Section 206-00.

**EXAMPLE** – The minimum thickness specification of the vehicle you are working on is 1.122 inches (28.5 mm). You measure the disc to be 1.200 inches (30.5 mm). Based on the smallest of the 4 measurements recorded, machining will require 0.024 inch (.61 mm) of thickness be removed.

The thickness after machining would be 1.176 (29.9 mm). This is greater than the minimum specification. The brake disc should be machined.
