Thoroughly read and understand ICC Software update instructions prior to rework.

ICC UPDATE - PROCEDURE

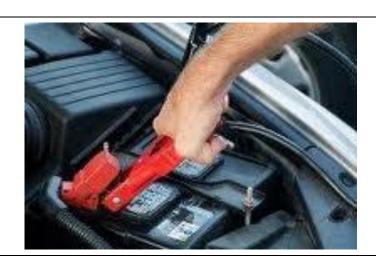
- Update the IDS to the latest level, 83.01 or later (if necessary)
- 2. Connect an external power supply to the vehicles battery and to the IDS.

Note: It is very important that the ICC and the IDS have full power available at all times during the ICC software upgrade process.

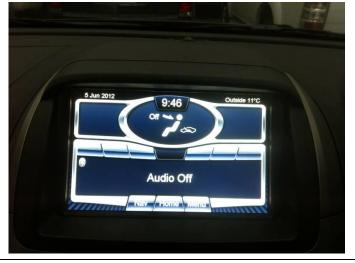
- 3. Turn off and disconnect all accessories on the ICC.
 - a) Audio
 - b) Climate control
 - c) Aux (I-pods, I-phones)
 - d) Bluetooth Un-bond all paired devices
 - e) Remove any attached USB hardware

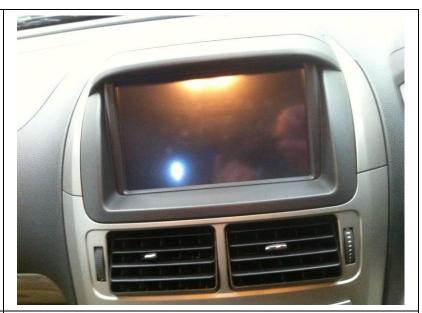
30. Once complete, the screen will stay blank for up to 5 minutes.

The ICC will reboot and the screen will turn ON. Titanium vehicles can take longer to reappear.

Do <u>NOT</u> remove USB stick at this stage.

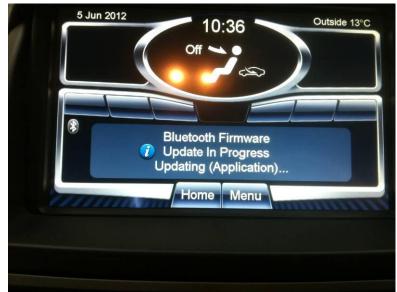
31. Once the screen has rebooted, the update includes a Bluetooth update, this will begin automatically.

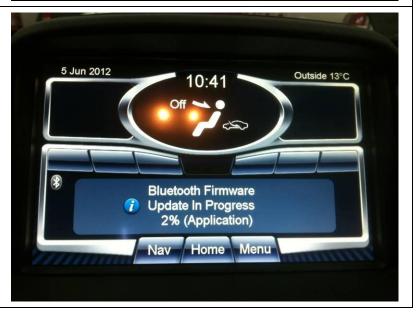
32. The ICC screen will show the Bluetooth update status in percentage.

NOTE: If the Bluetooth Firmware update does not pass 17%, simply press the retry button on the IDS. This will relaunch the Bluetooth Firmware update.

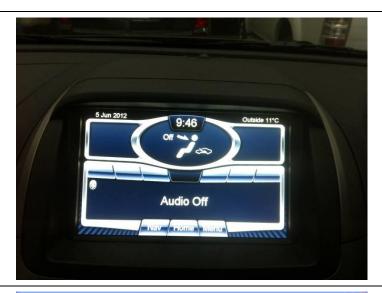
33. Once the Bluetooth update has completed, the ICC screen should return back to its original screen.
