FOR INSTALLATION ON DRIVER'S SIDE ONLY

FORD MAVERICK TAILGATE ASSIST

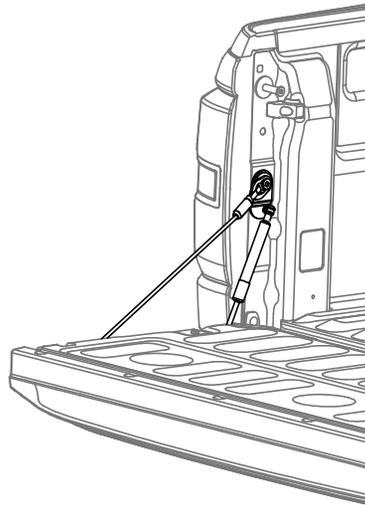
BALL MOUNT
PLATE

BOLT

LOWER
BALL MOUNT

SHOCK

TAILGATE
FASTENER

ITEM	QTY
BALL MOUNT PLATE	1
SHOCK	1
BOLT	1
LOWER BALL MOUNT	1
TAILGATE FASTENER	1

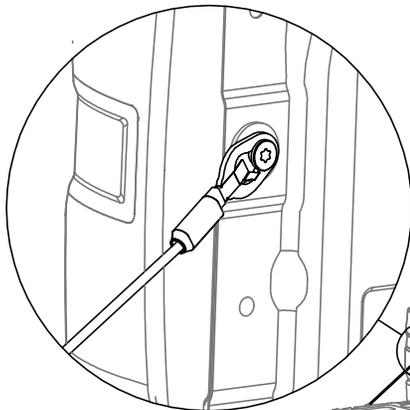
STEP 1)

Pull on the spring clip and remove the tailgate cable. Use a Torx T50 socket to remove the cable bolt.

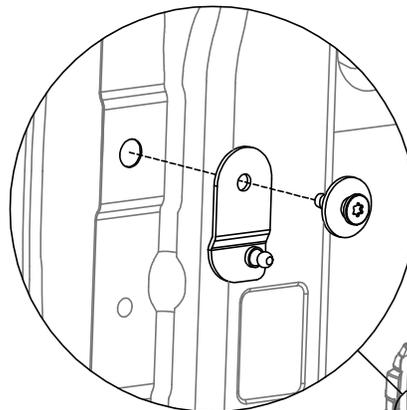
STEP 2)

Install the bolt removed from the previous step, through the hole in the ball mount plate, and back into the hole. Tighten the bolt with the T50 socket.

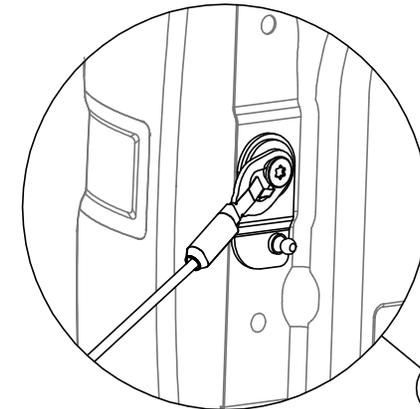
STEP 3)

Install the cable back onto the cable bolt.

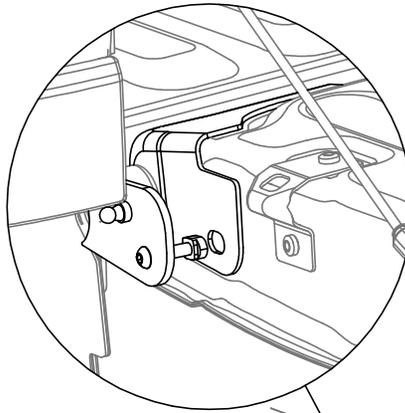
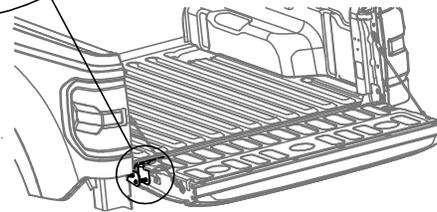
STEP 5)

Align the tailgate fastener with the slot in the tailgate.

Insert the tailgate fastener into the slot.

Rotate the bolt 90° to align tailgate fastener notches with edges of the slot.

Pull out on lower ball mount plate to engage tailgate fastener into slot.

While pulling out on the lower mount plate, tighten bolt with a 5mm allen wrench.

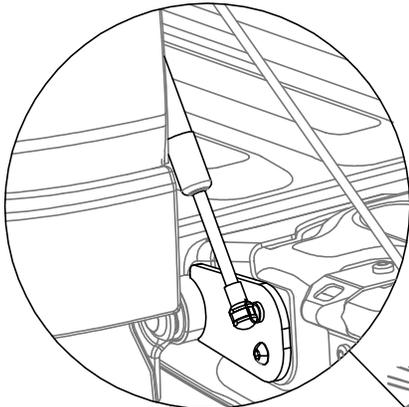
STEP 6)

After lower ball mount is attached, install the small end of the shock to the ball mount.

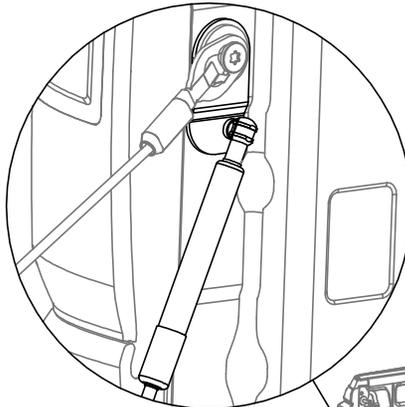
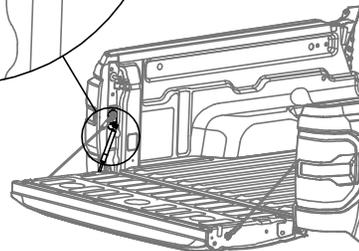
STEP 7)

Install the larger end of the shock to the ball mount plate.

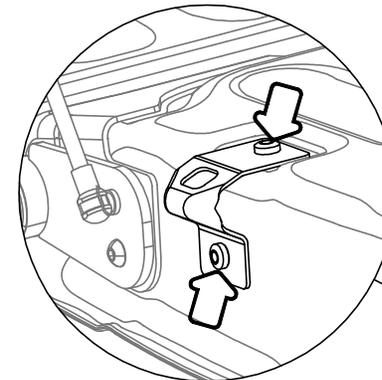
STEP 8)

The bottle opener on the driver's side of the tailgate must be removed. Using a T30 torx bit, remove the two screws attaching the bottle opener.

If the bottle opener is not removed, it will interfere with the shock and prevent the tailgate from closing.
